The role of Passive Fire Protection

Dr Gabrielle Peck, BSc(Hons), Ph.D., MRSC,
Technical Director

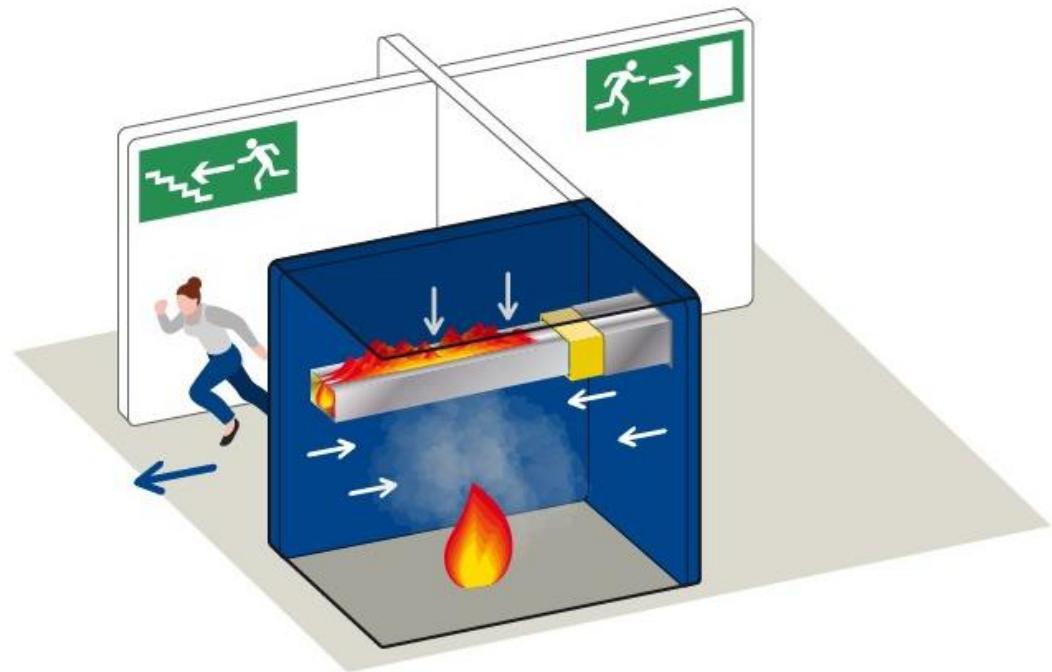
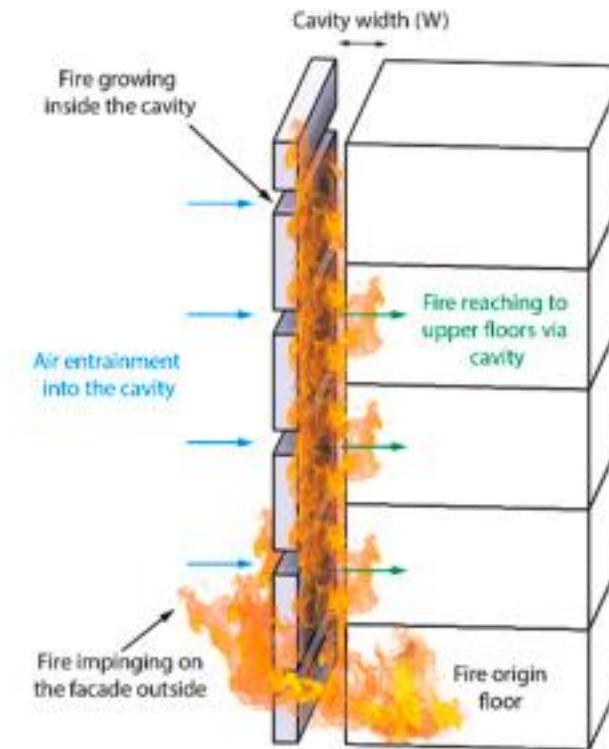
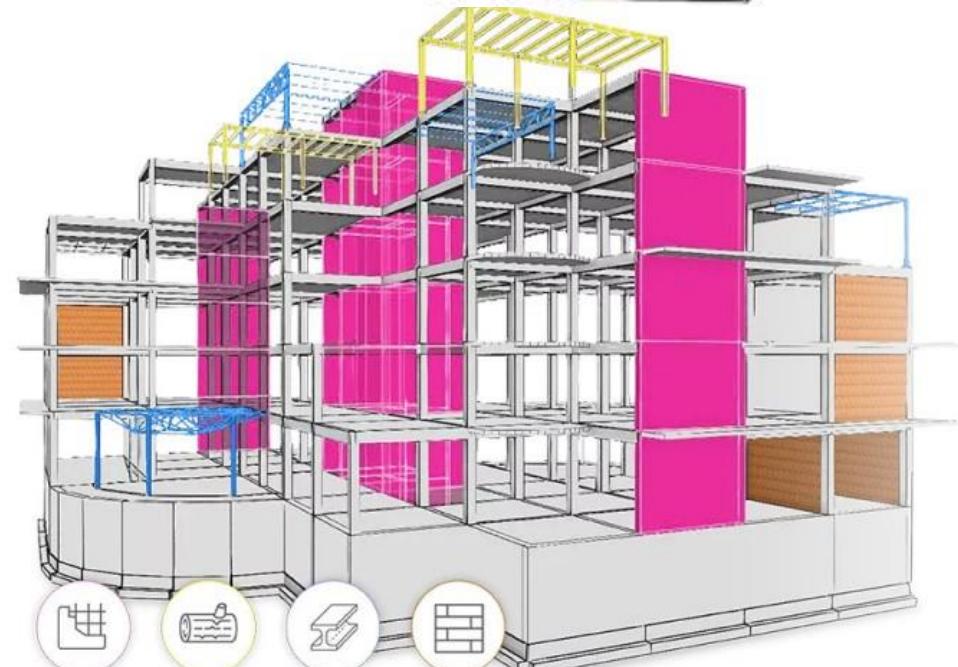
Key elements of a building

Passive fire protection (PFP) relies on integral building elements to:

- **resist fire spread**
- **maintain structural stability**
- **control smoke spread**

- **Structural Framework**
- **Compartmentation Barriers**
- **External Envelope**
- **Service Integrations**

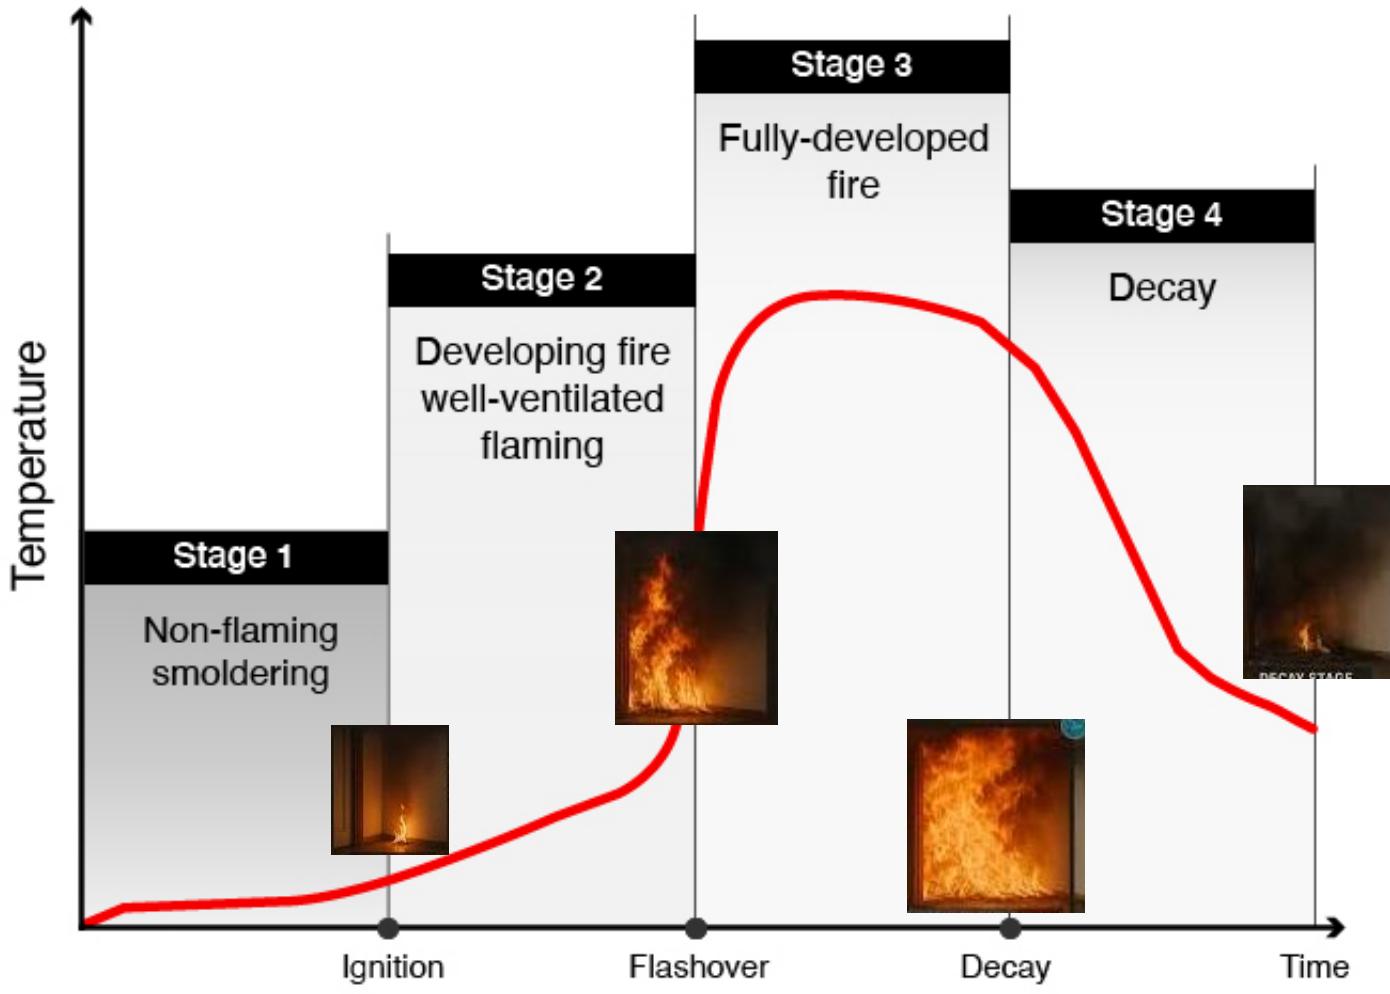
Fire stages and development

What would happen if an
unprotected building caught fire?

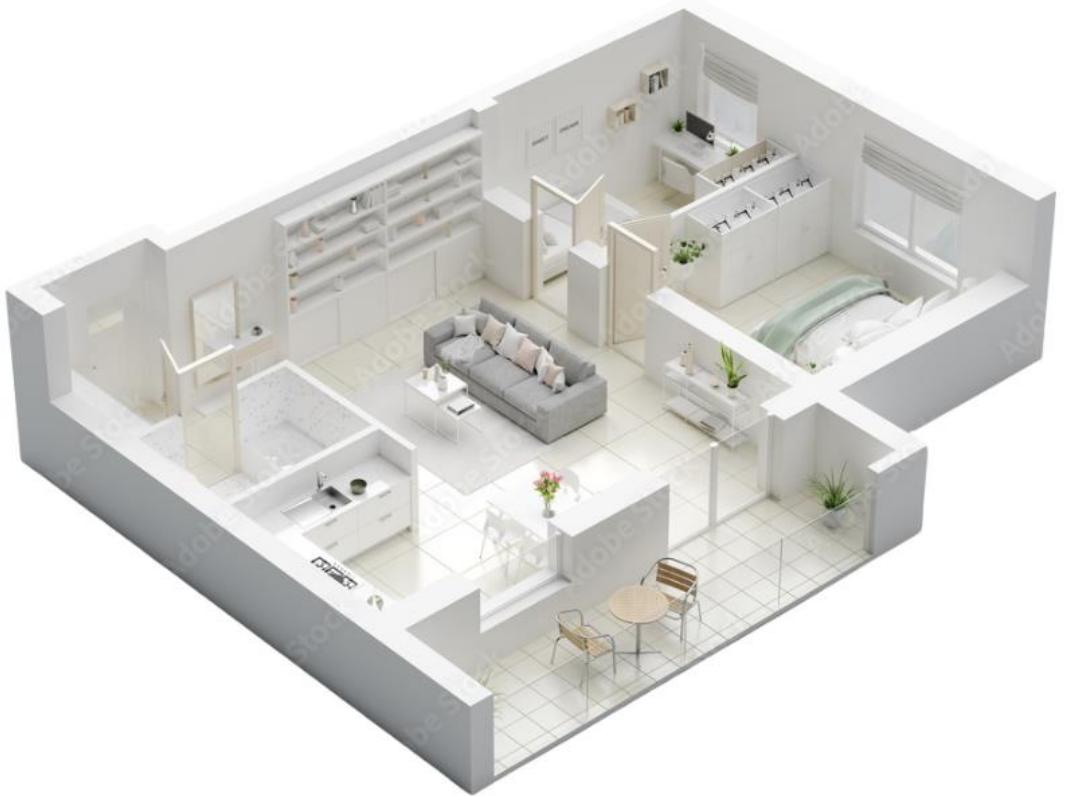
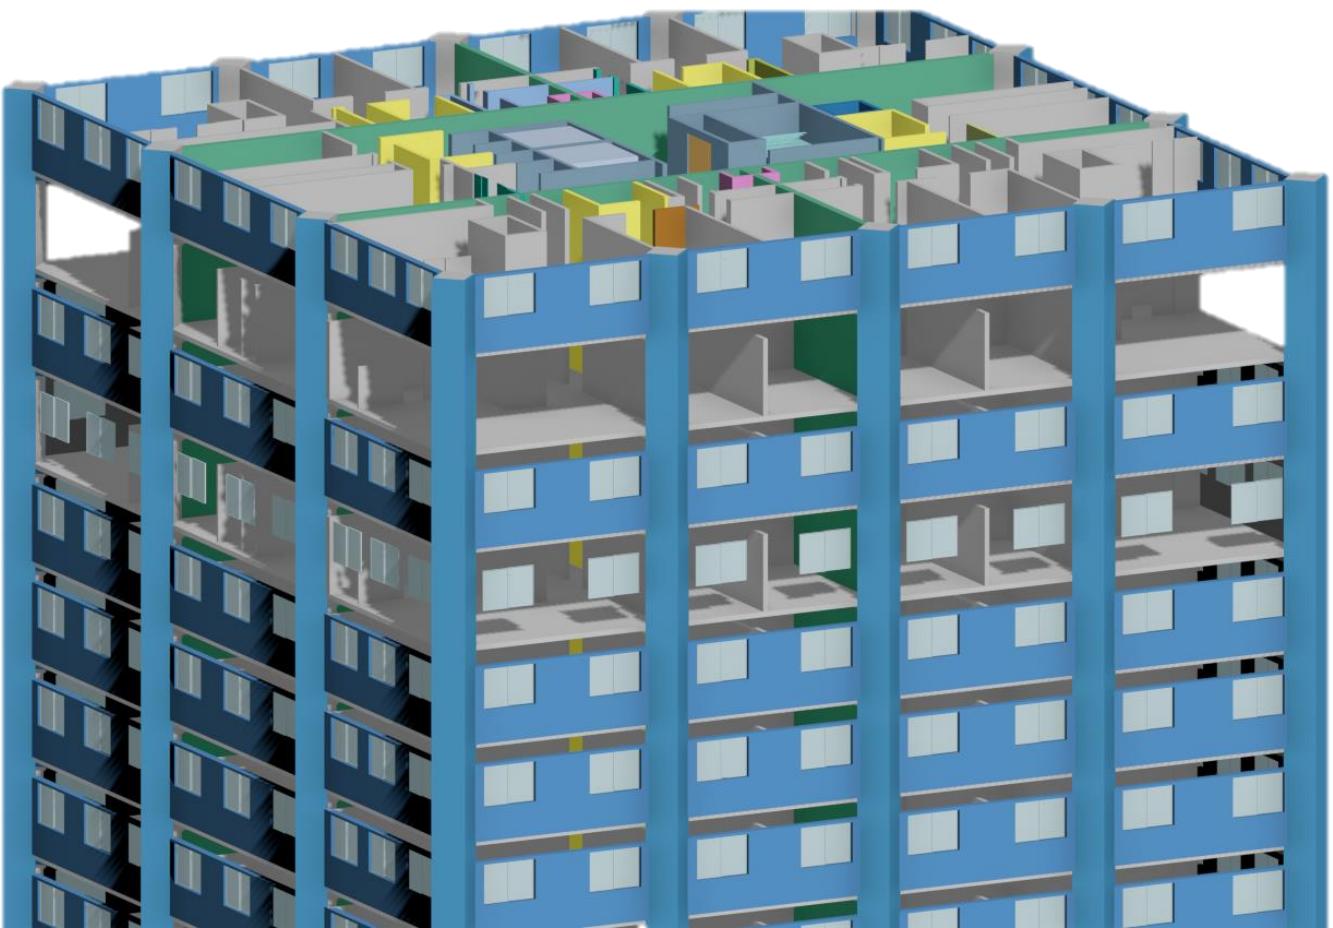
- Flashover is the rapid transition in a fire where all combustible materials in an enclosed space ignite nearly simultaneously due to intense heat, typically occurring when temperatures reach 500–600°C (932–1112°F), causing a sudden spread of flames and extreme danger.

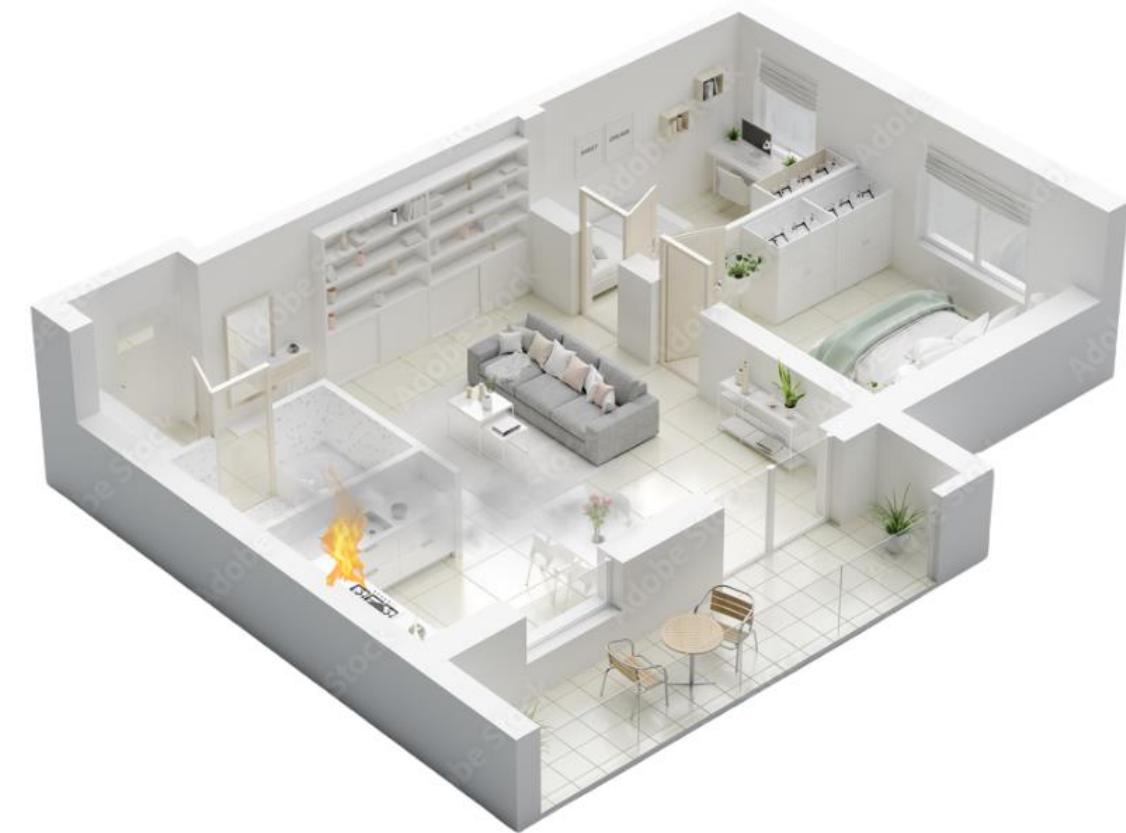
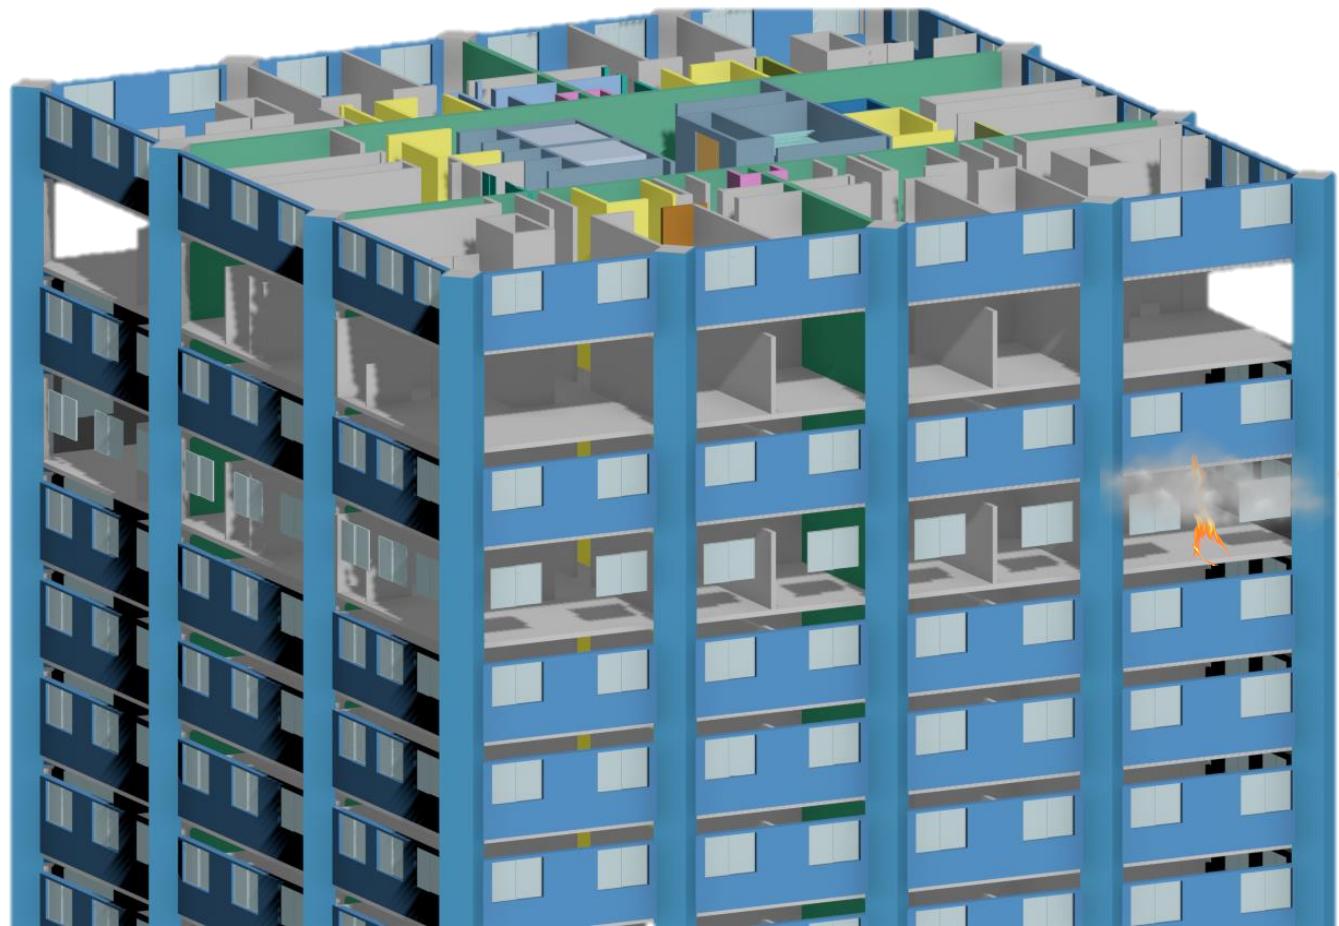
0 to 5 mins

A small fire in a room begins.

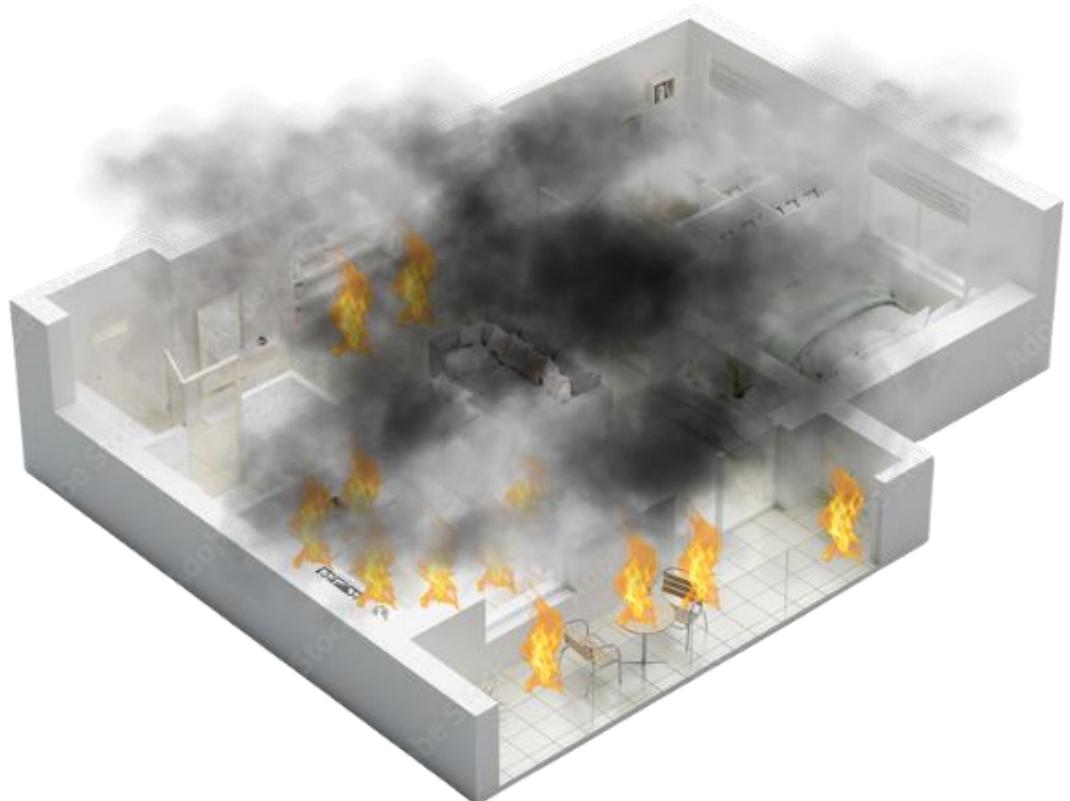
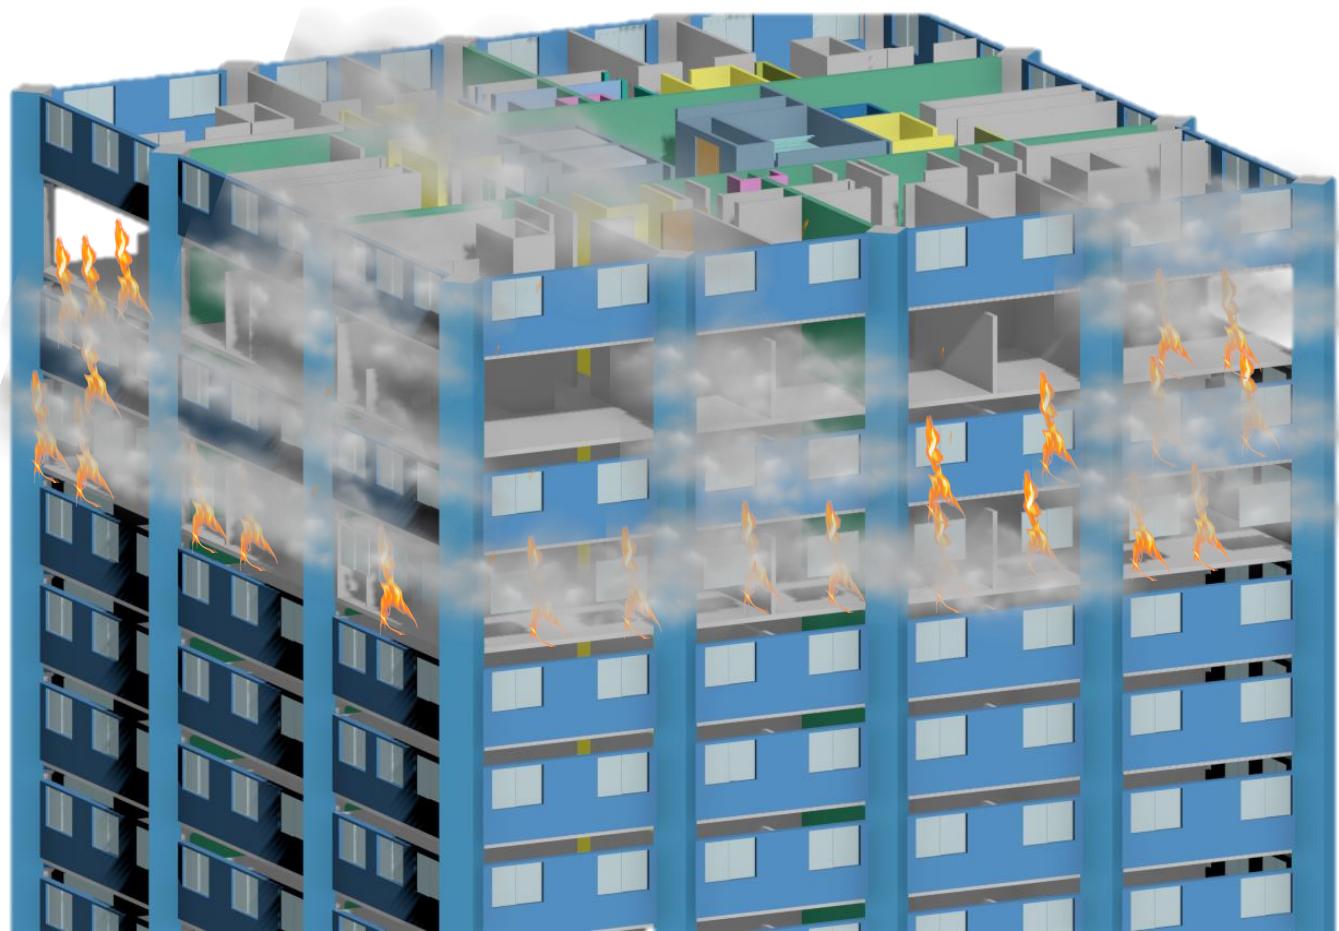
Structural Instability begins (20-30 min).

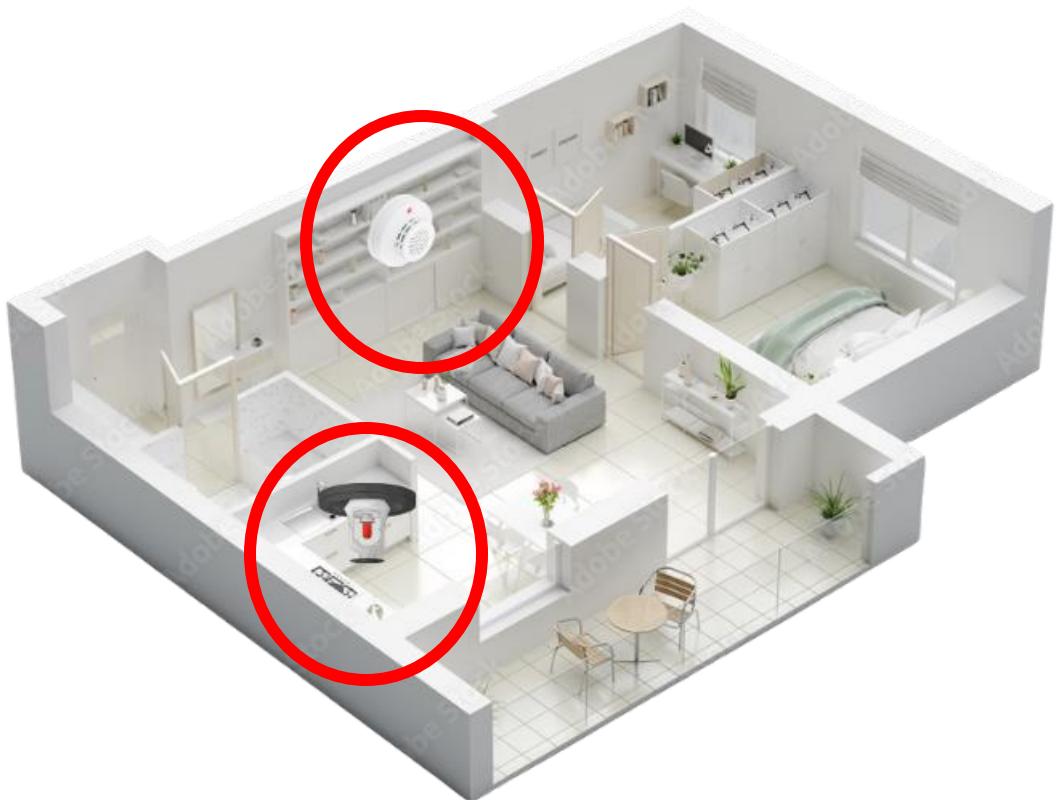
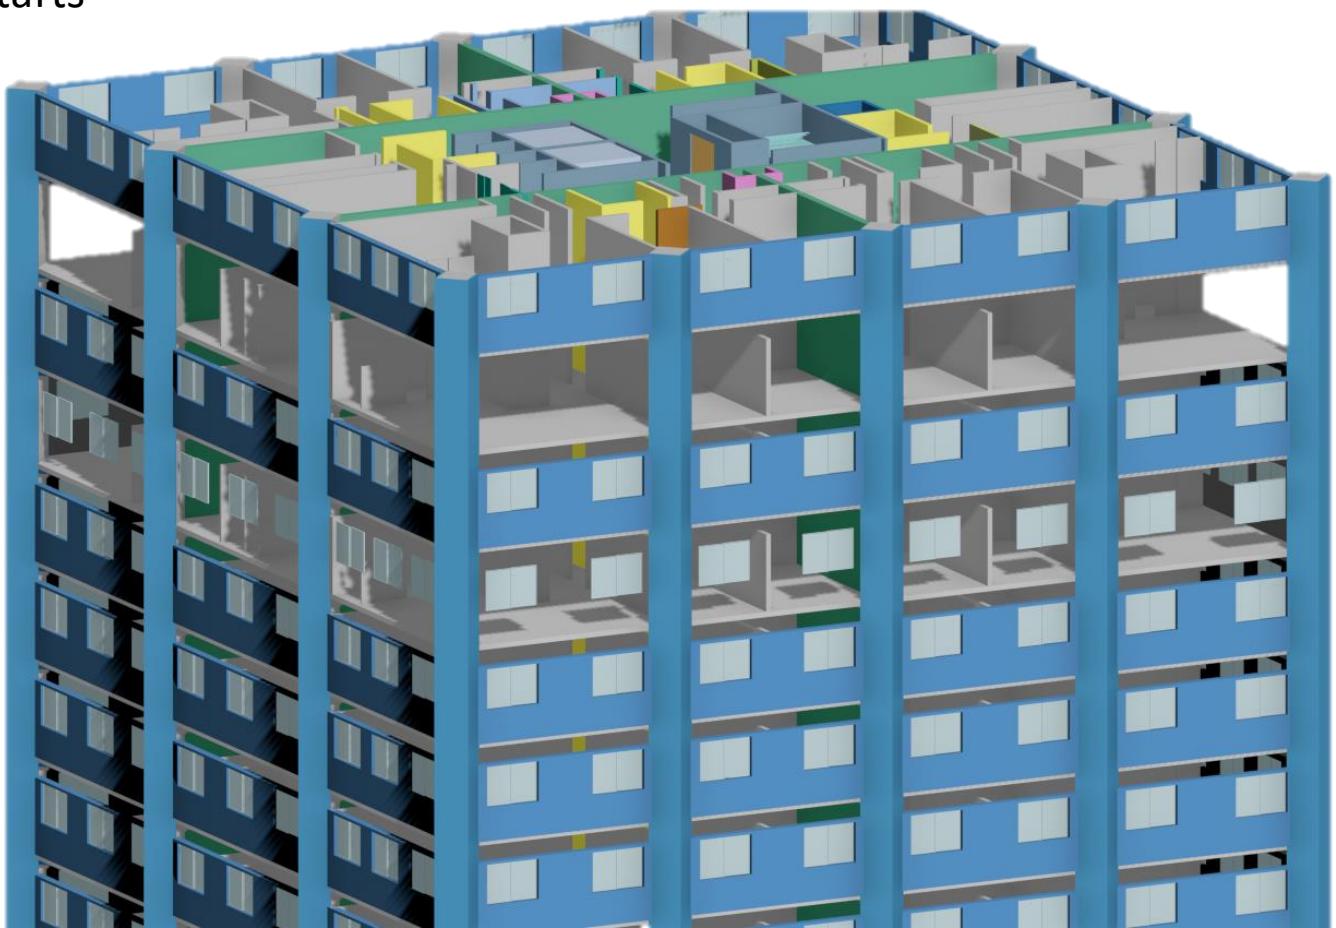
Ignition (0-5 min): Flame sparks and a small fire starts

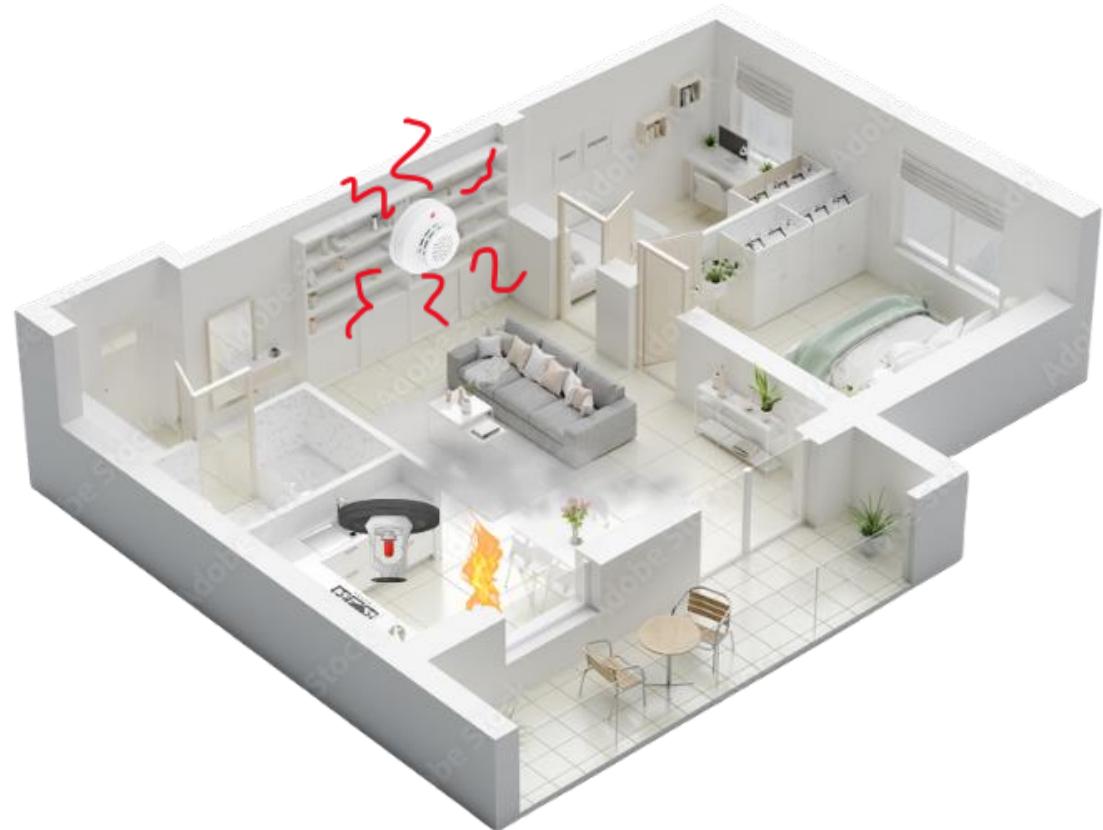
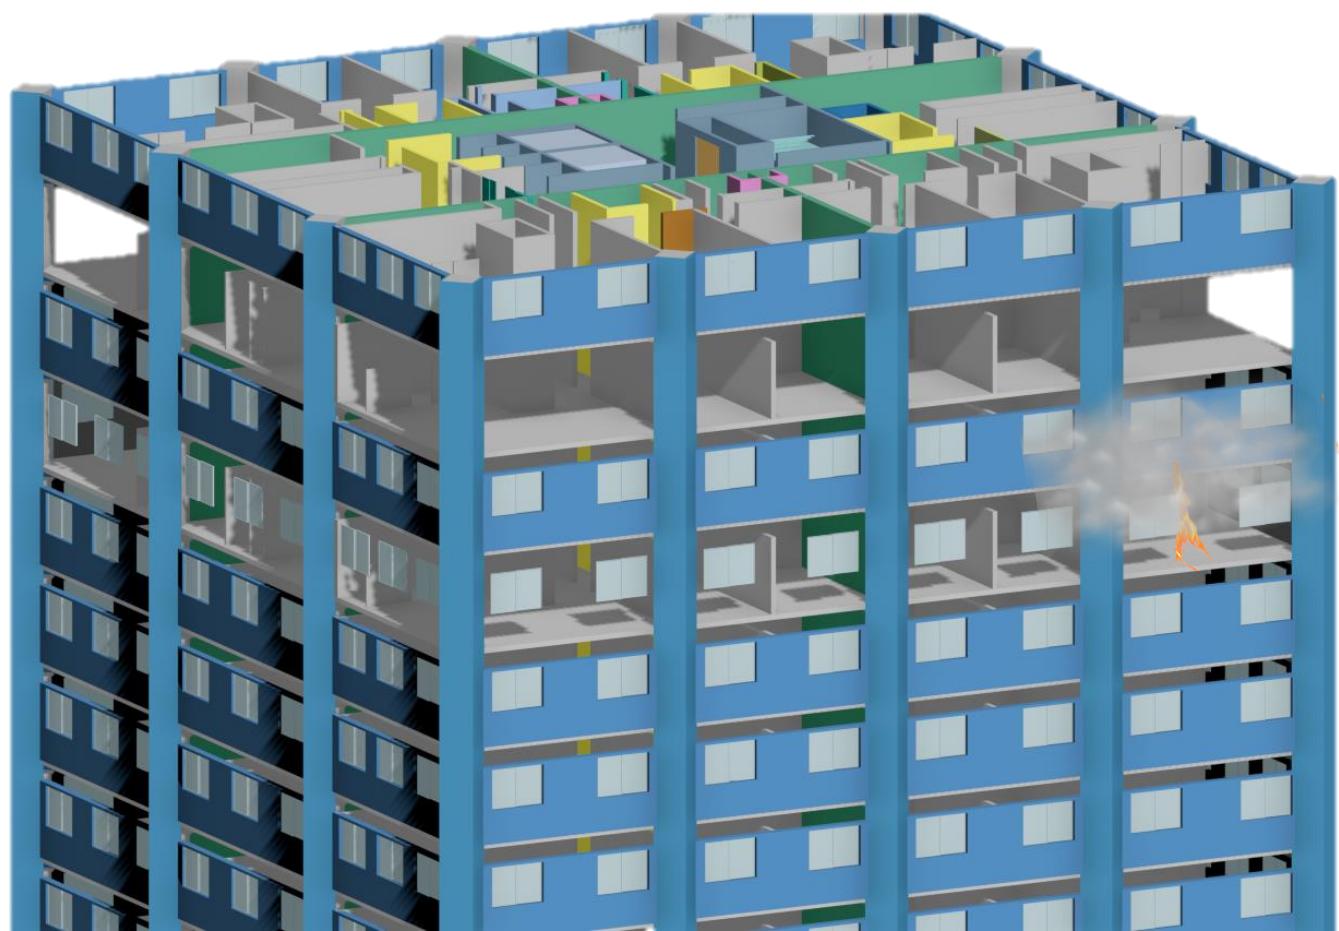
Detectors sense 60°C rise and the alarms start. Evacuation begins, but smoke still spreads and rises.

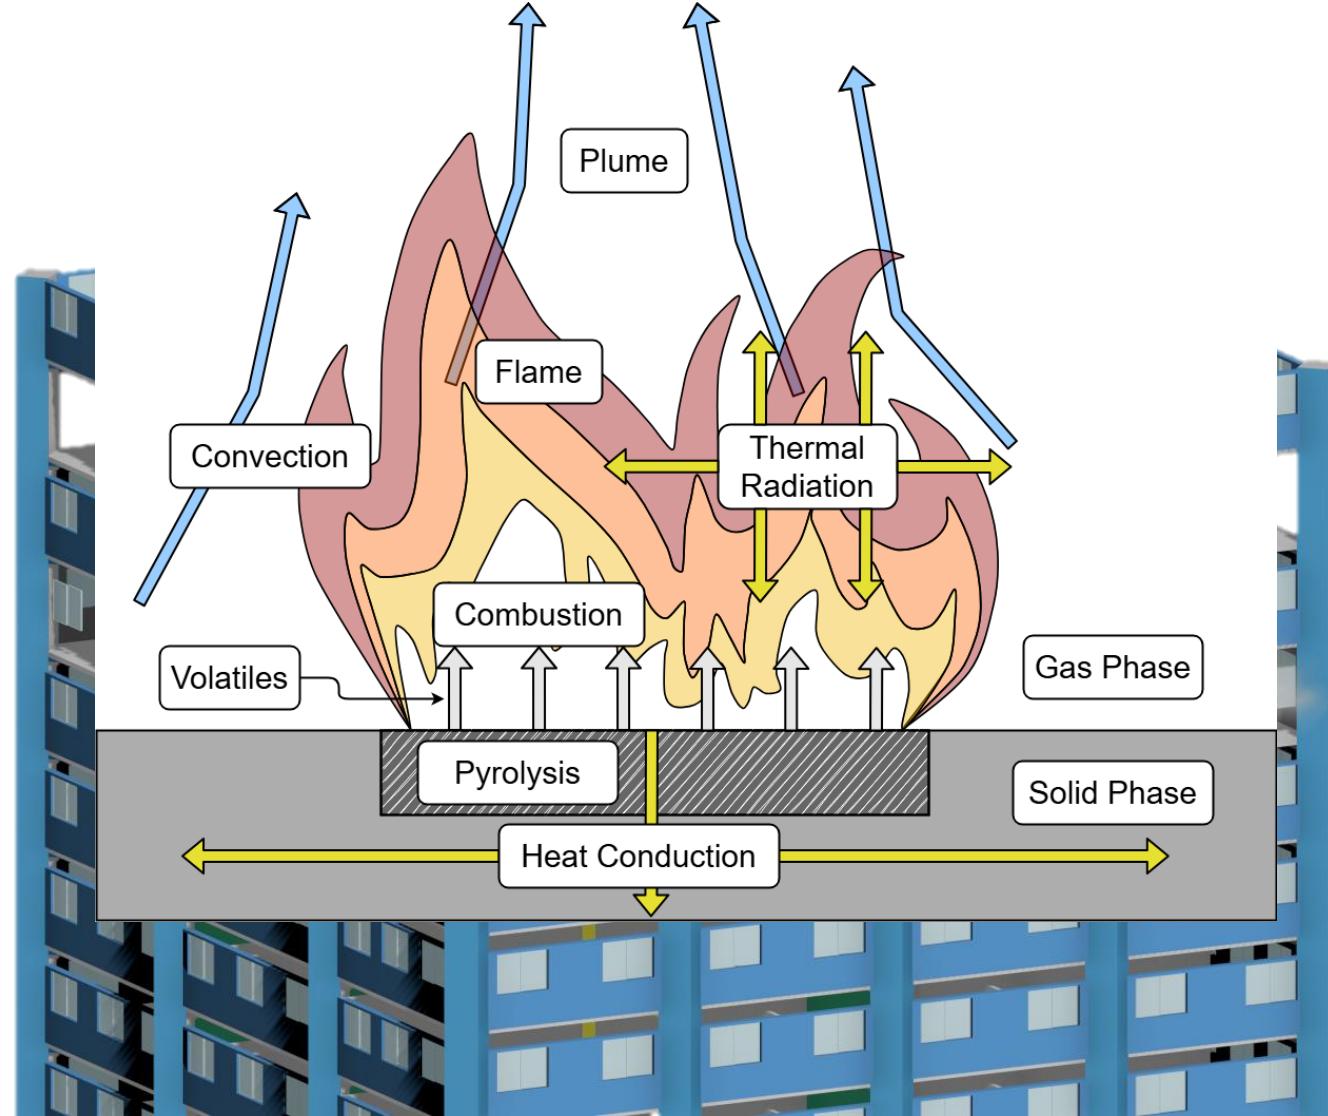
For very large fires or rapidly growing fires, sprinklers may activate but become overwhelmed.

Water mist can further aerosolize smoke, exacerbating toxicity and visibility issues.

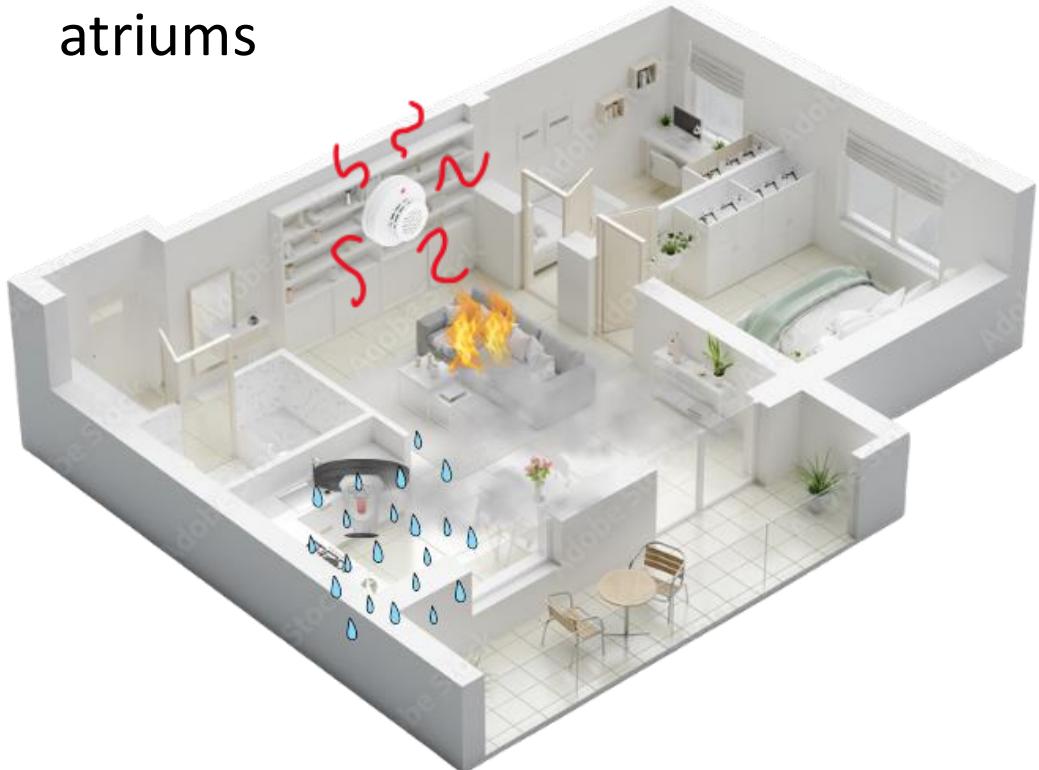
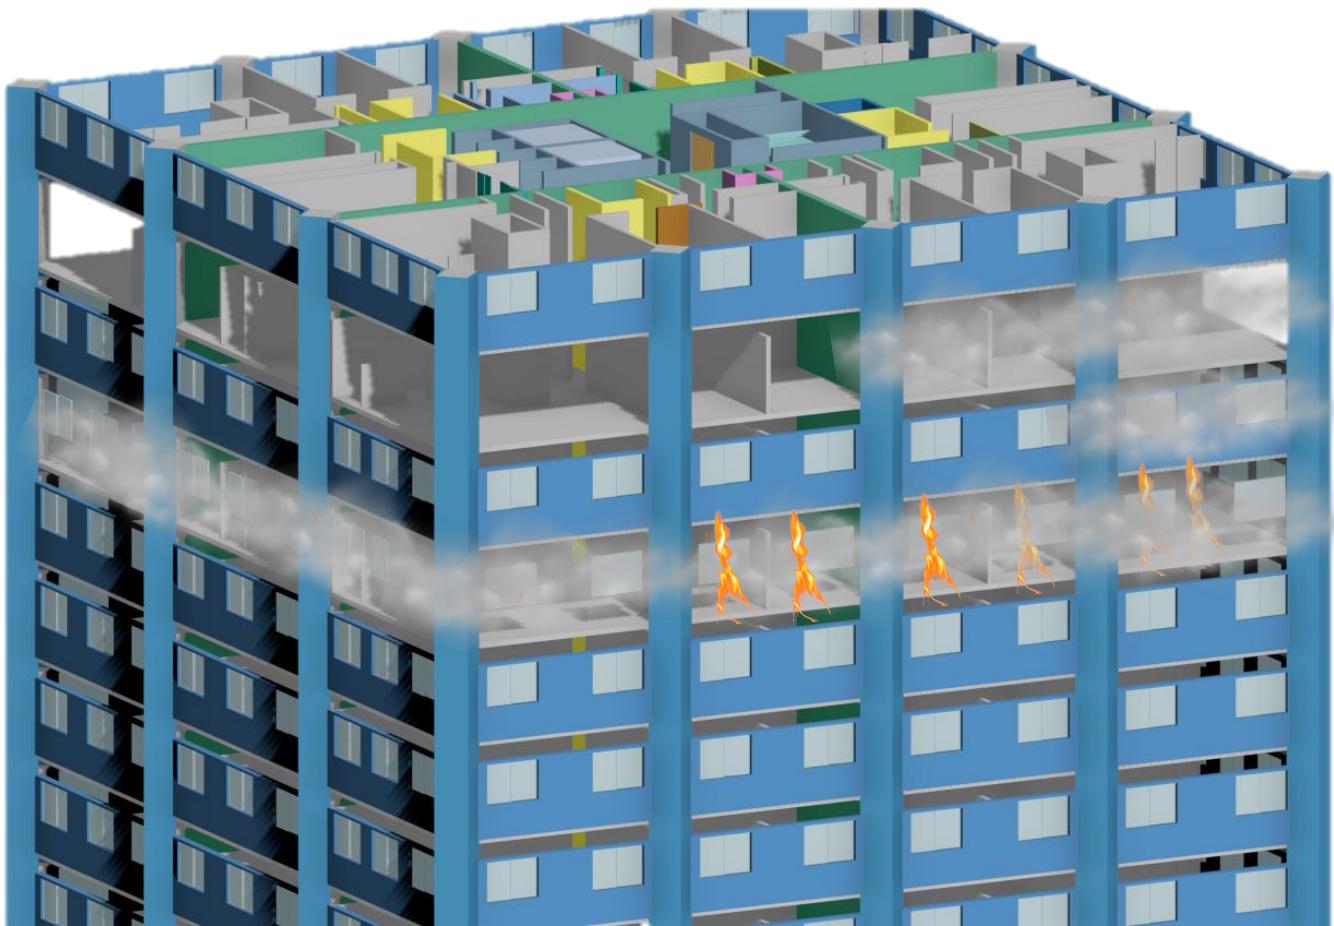
5-15 mins

sprinklers activate at 68°C, discharging water, capping fire growth. Flames recede, but water mist aerosolizes smoke, **aiding spread**. Horizontal smoke migration through unsealed doors fills atriums

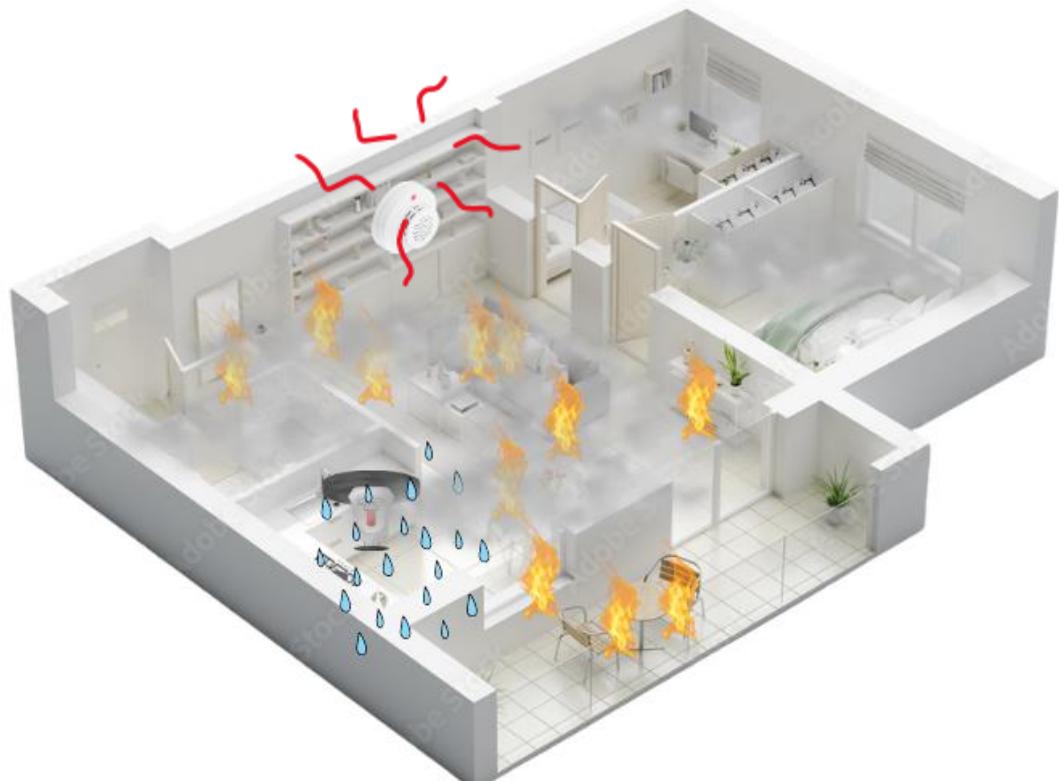
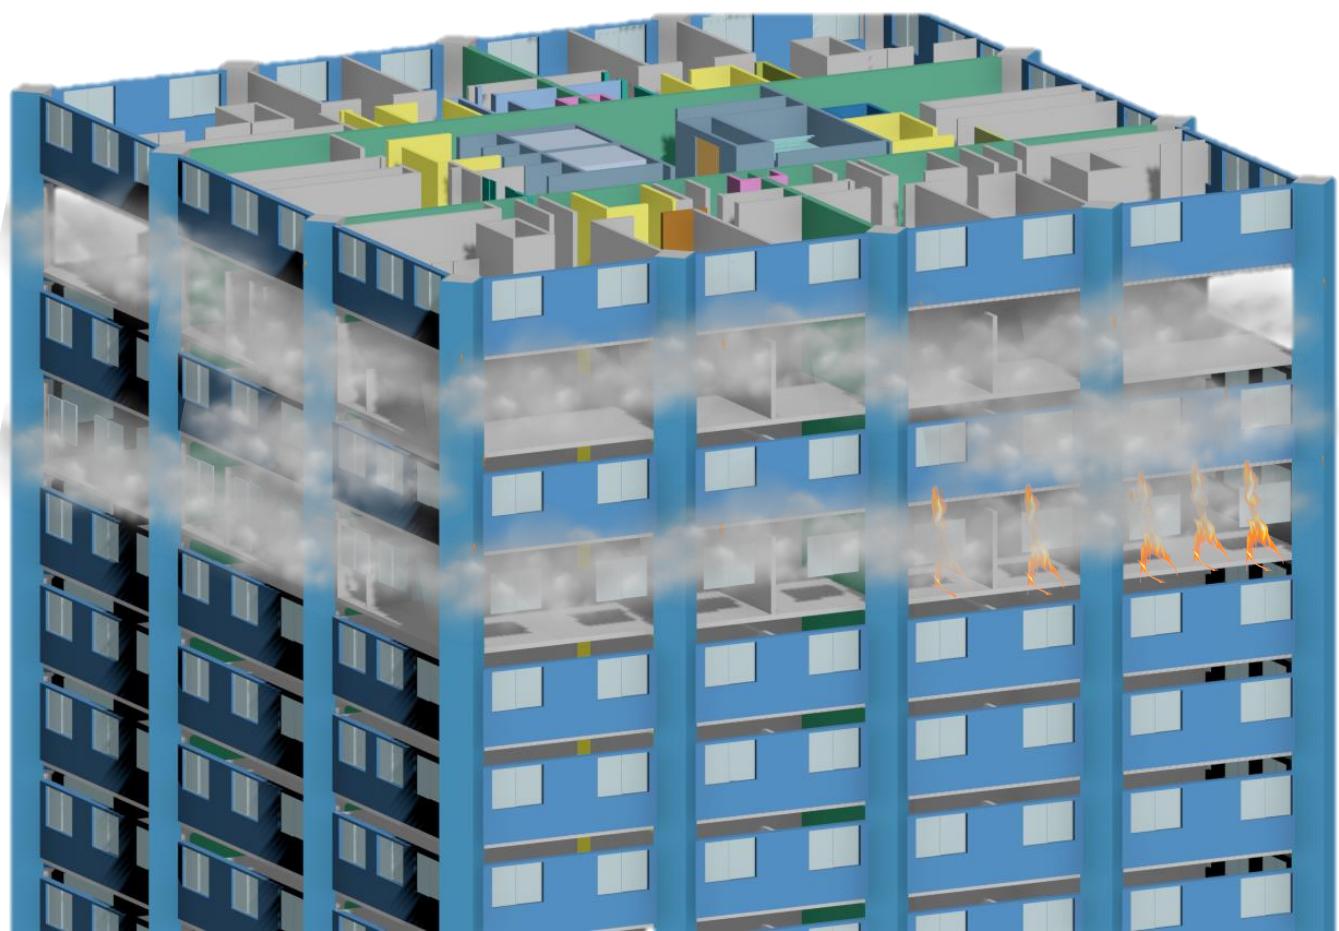
15-20 mins

Flashover is mitigated (15-20 min): sprinklers prevent uniform ignition. BUT vertical shaft convection propels unconfined smoke upward, infiltrating vents.

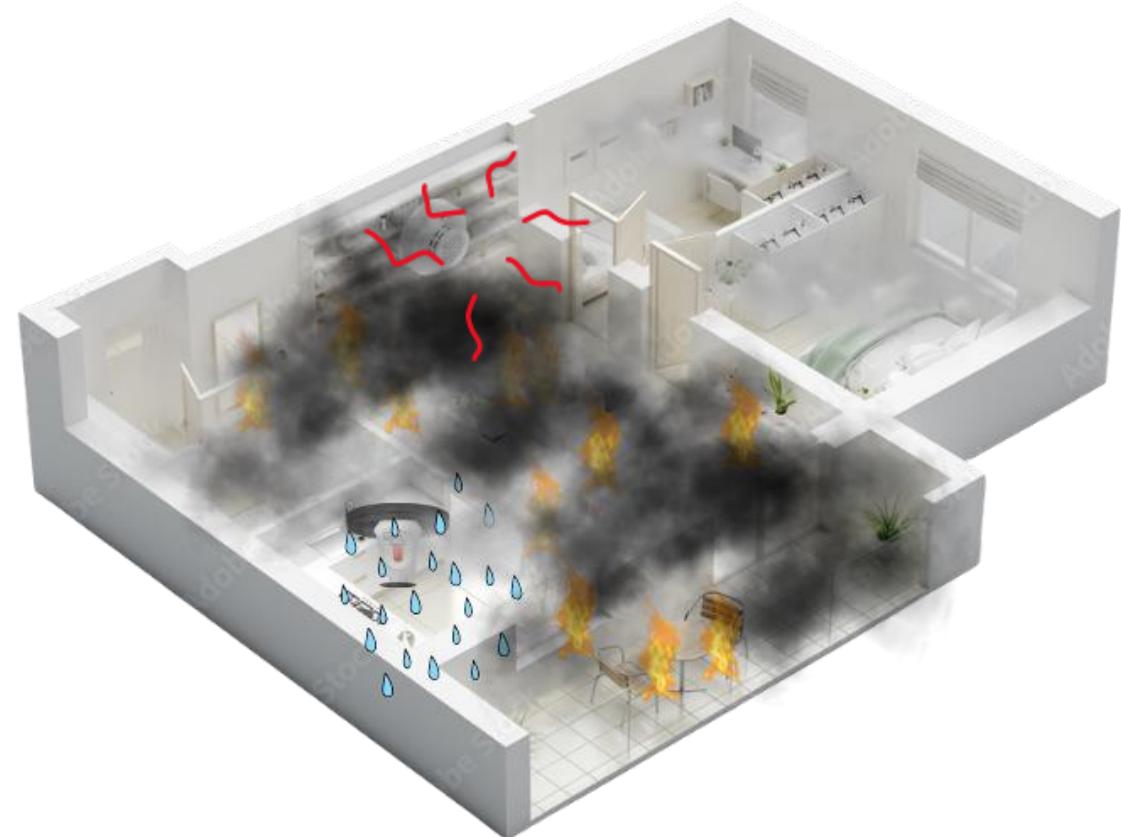
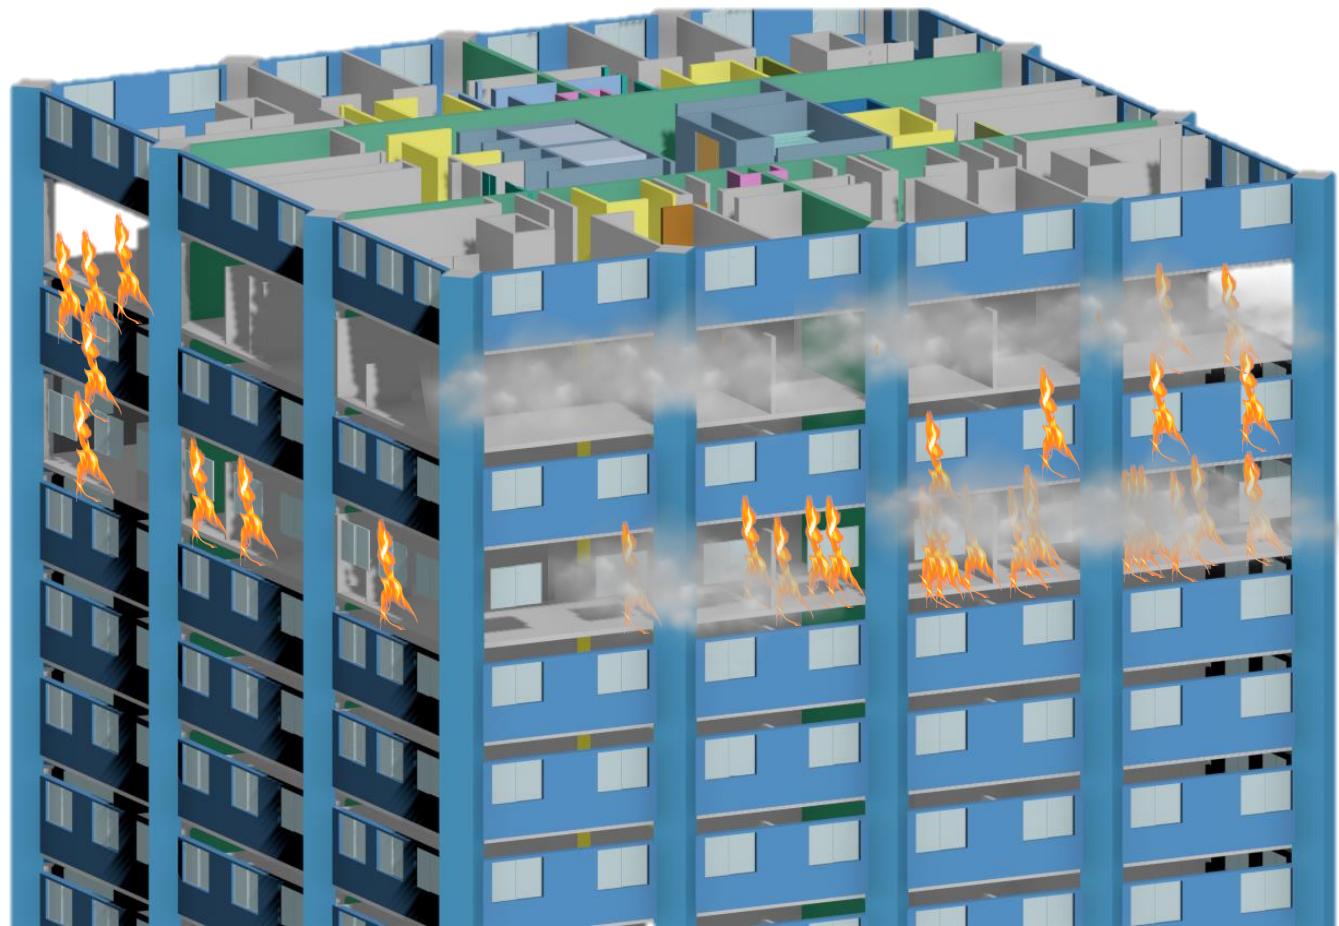
Fully Developed (20-45 min)

Localized to origin room, **heat begins to warp steel columns (concrete may spall)**.

No collapse imminent, but smoke permeates floors of the building and oxygen dips to 12%. Sprinklers wet distant areas, **BUT** occupants **ARE STILL AT RISK** from inhalation. Smoke flood exit ways, making escape difficult.
