The role of Passive Fire Protection

Dr Gabrielle Peck, BSc(Hons), Ph.D., MRSC,
Technical Director

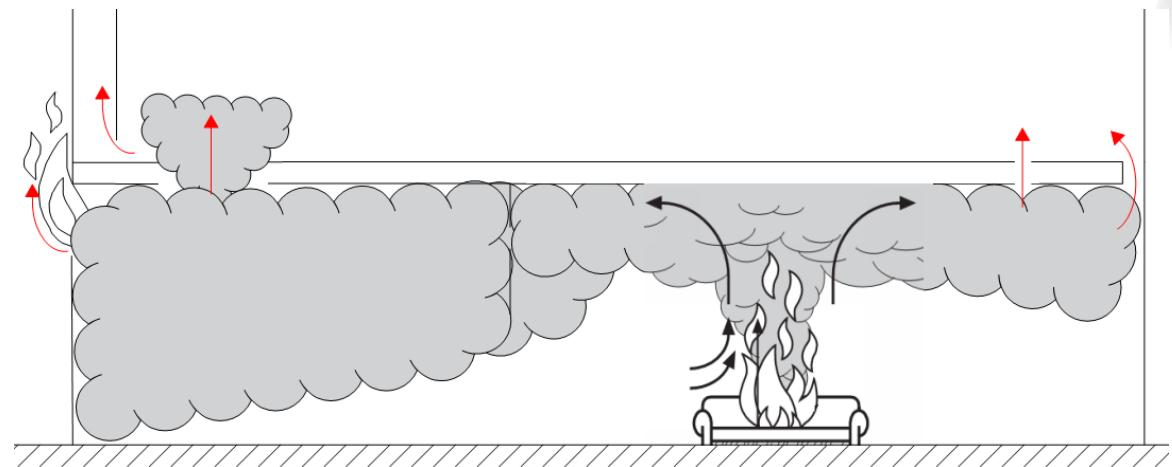
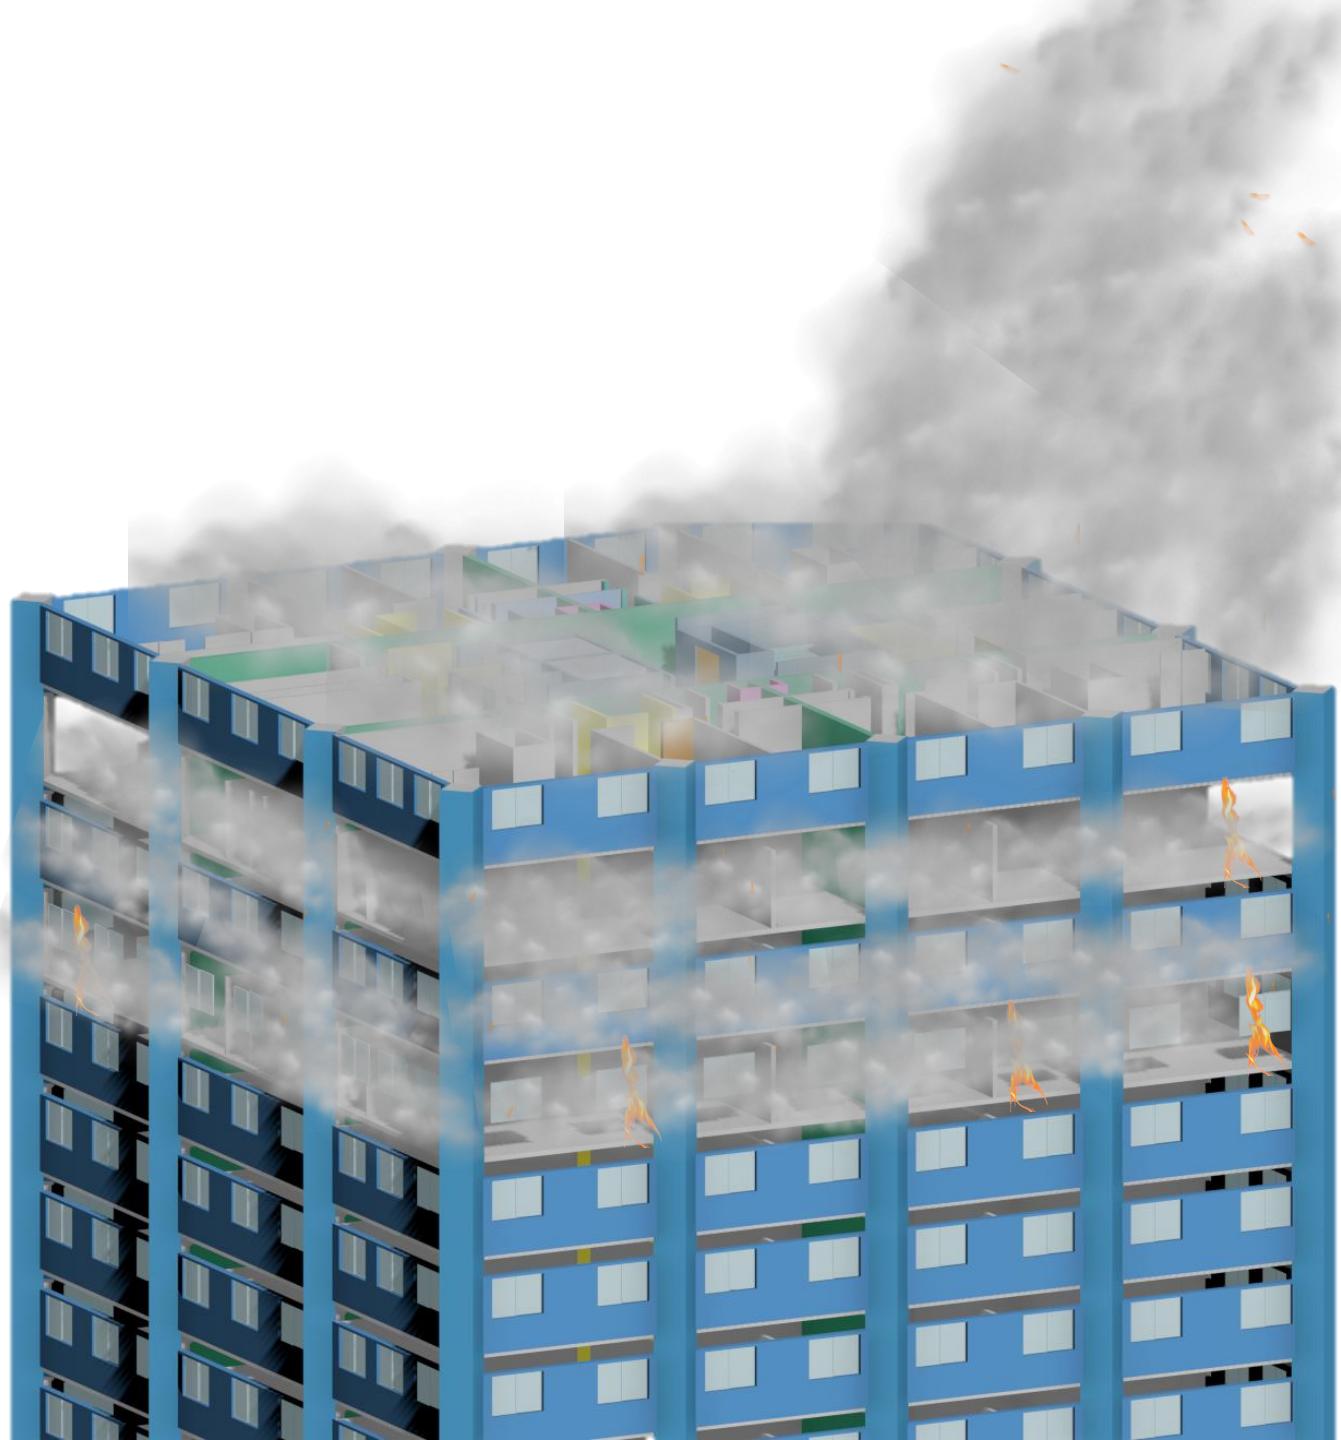
>45 mins

Water suppression douses embers.

Large volumes of smoke are produced. As there is no compartmentation, smoke travels through the building, flooding egress routes.

Those unable to escape unassisted are at risk of incapacitation and are reliant on rescue from firefighters.

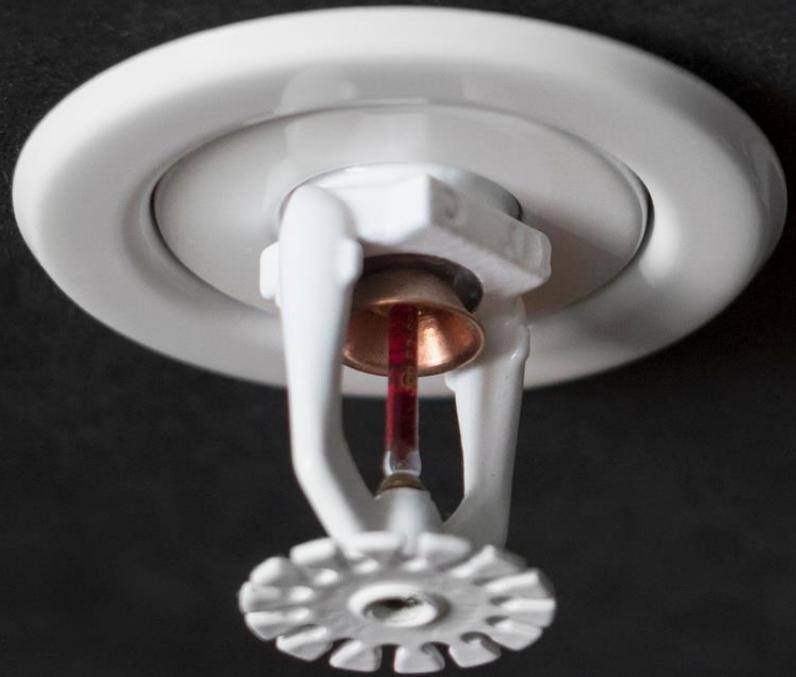
The statistics

**Sprinklers are
effective 89% of the time**

Key cause of failure:

- Delayed onset
- Failed onset (7%)
- Fire grew too large too fast, and the sprinklers failed to contain fire

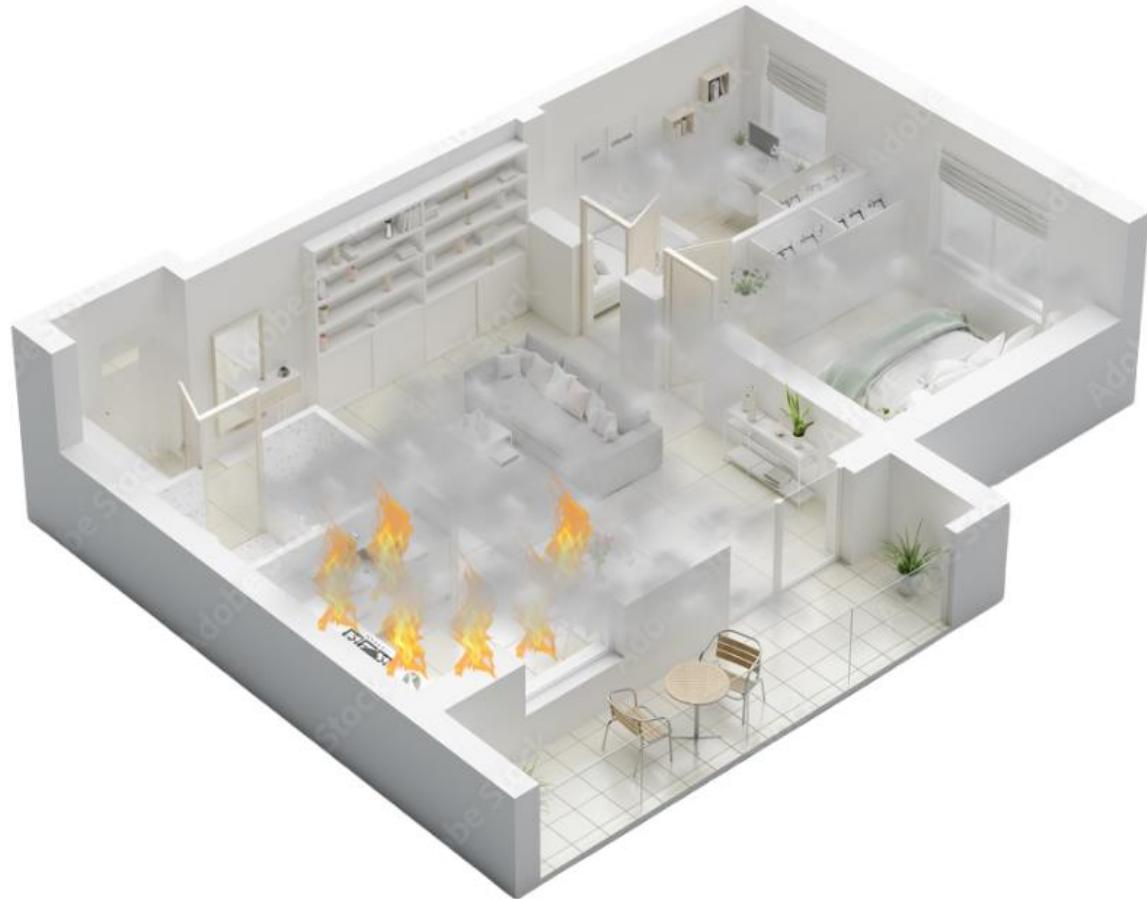
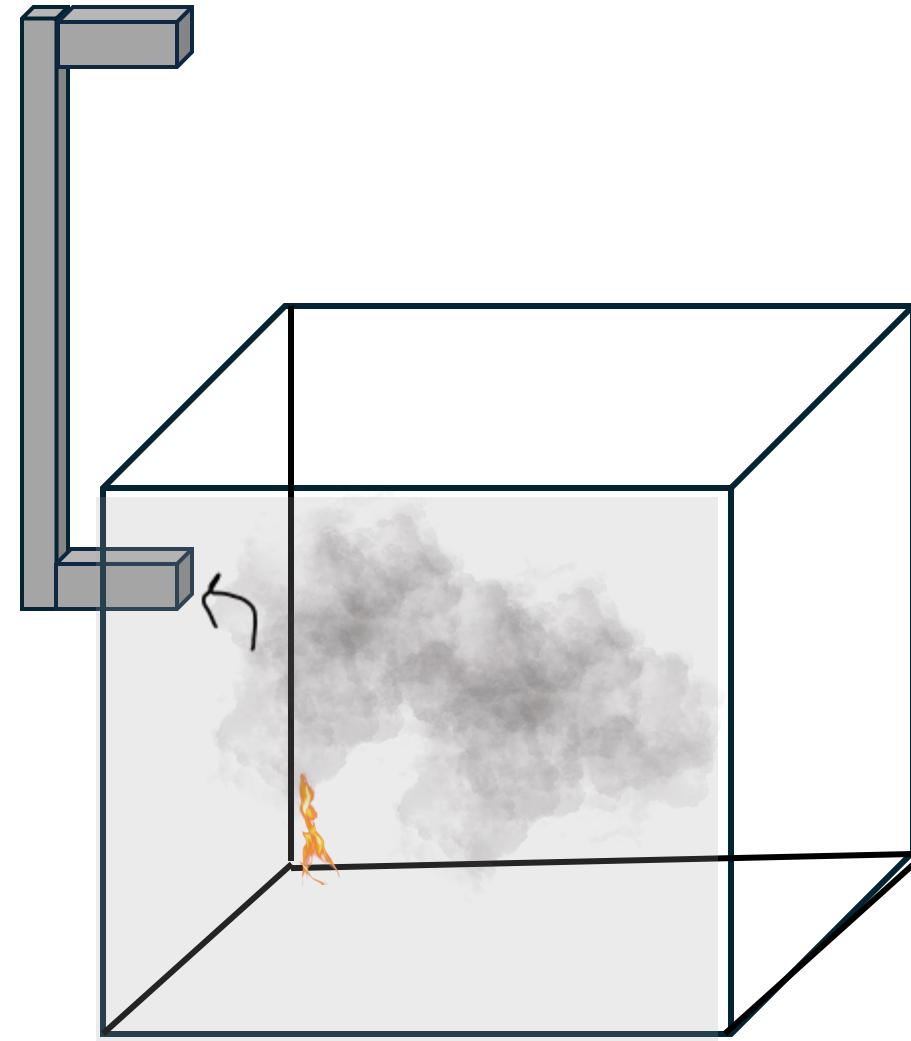
No protection causes 3 key problems:

- **Smoke spread**
- **Flame spread**
- **Risk of structural collapse**

Active fire protection (sprinklers and alarms) stops the fire growing too large;

Passive fire protection stops the fire and smoke spreading around the building

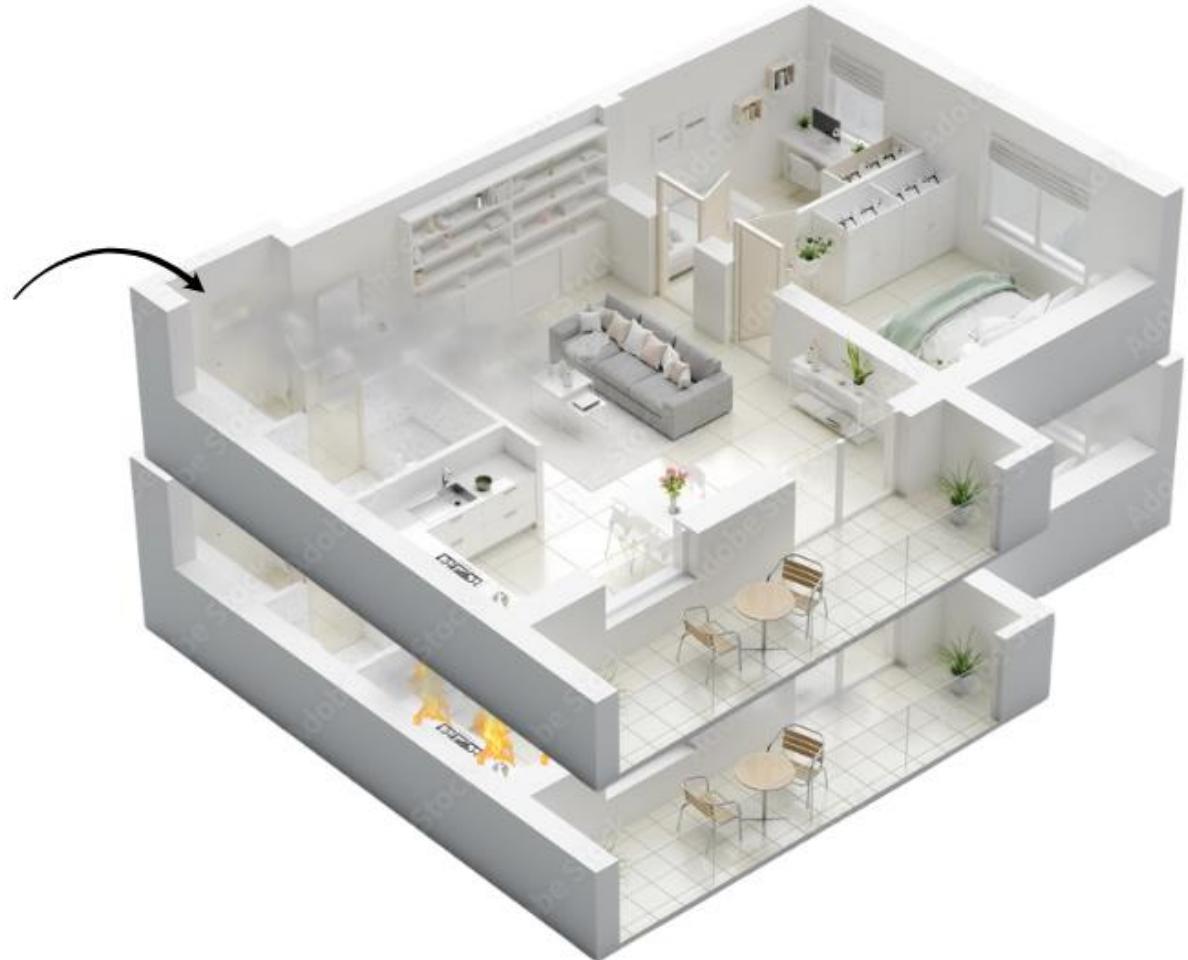
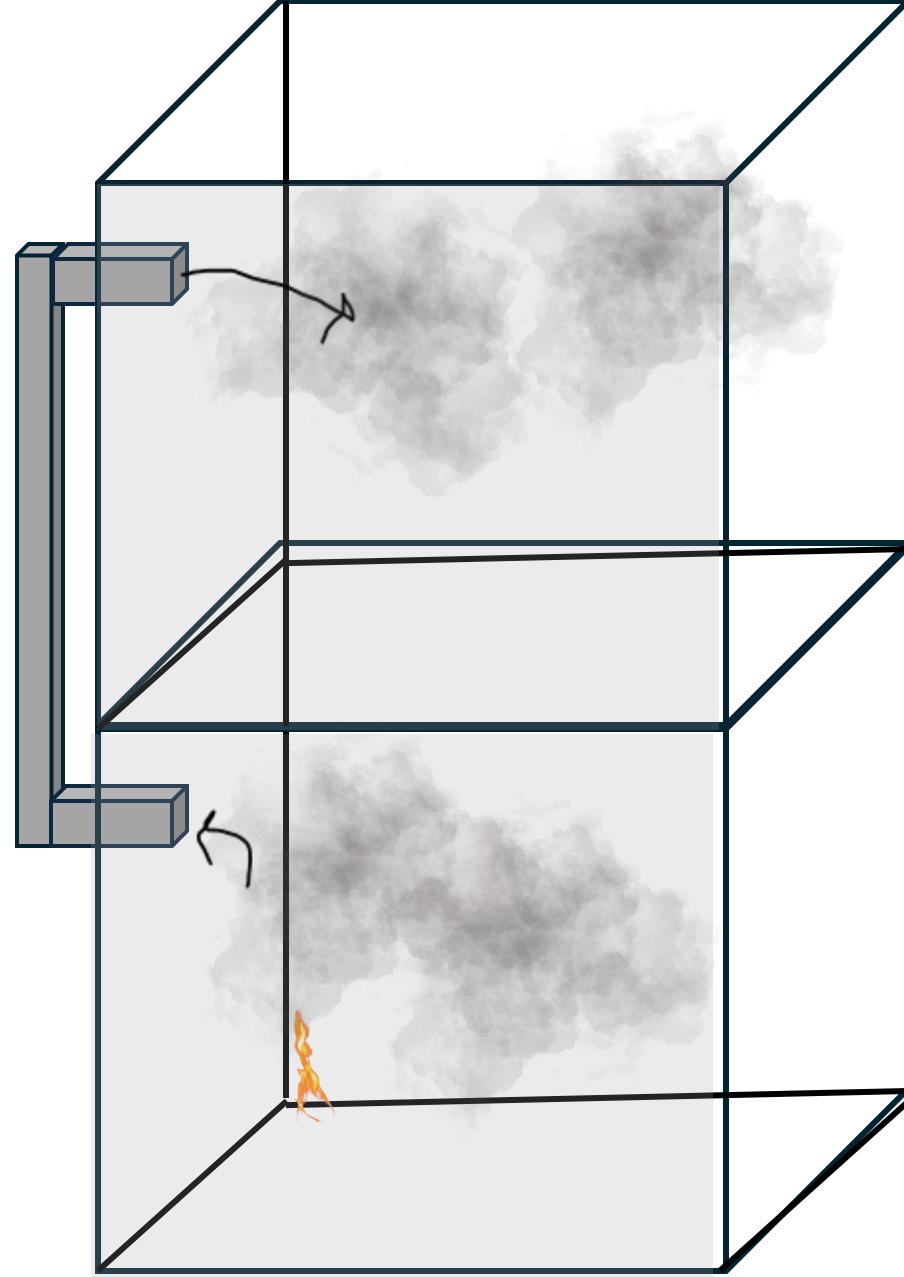
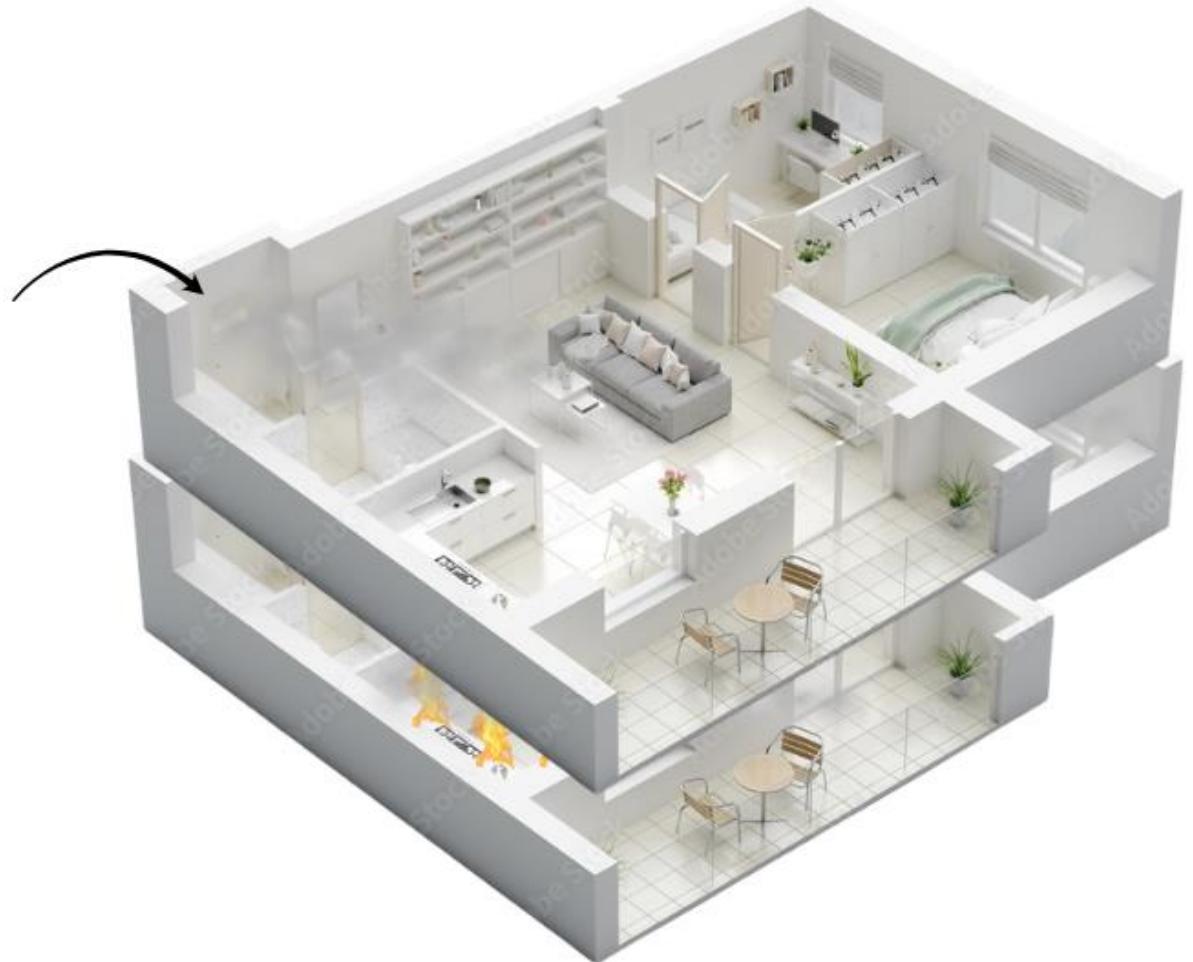
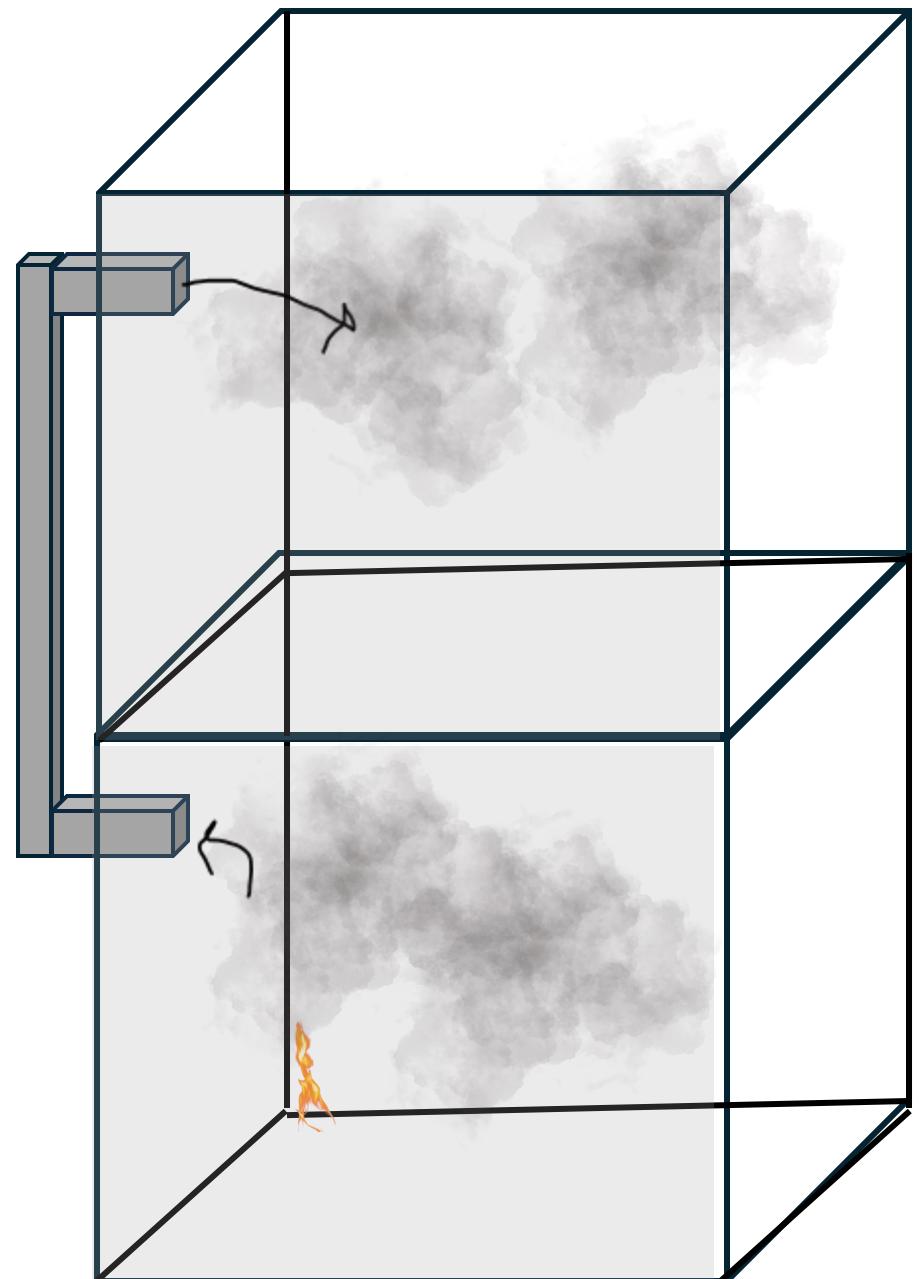
Smoke spread still occurs with sprinklers and alarms!

Smoke will move through openings to other parts of the building.
This is how occupants die in fires despite not being near the room of the fire.

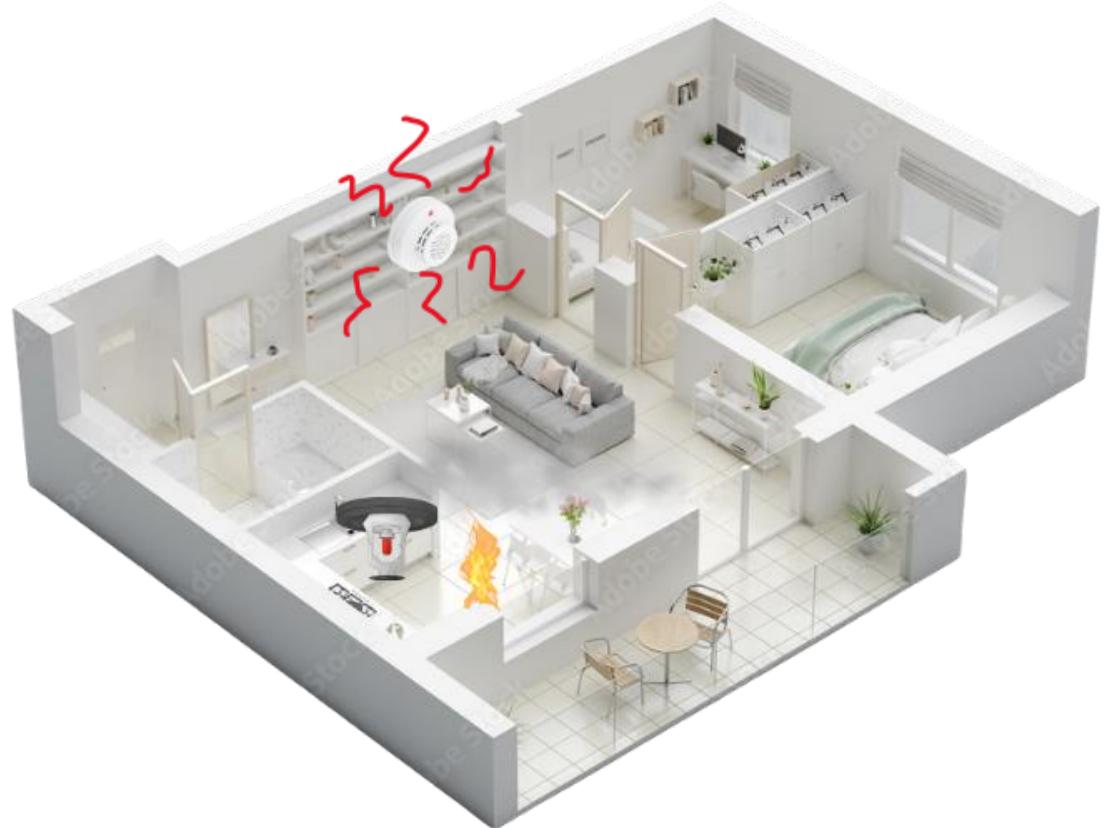
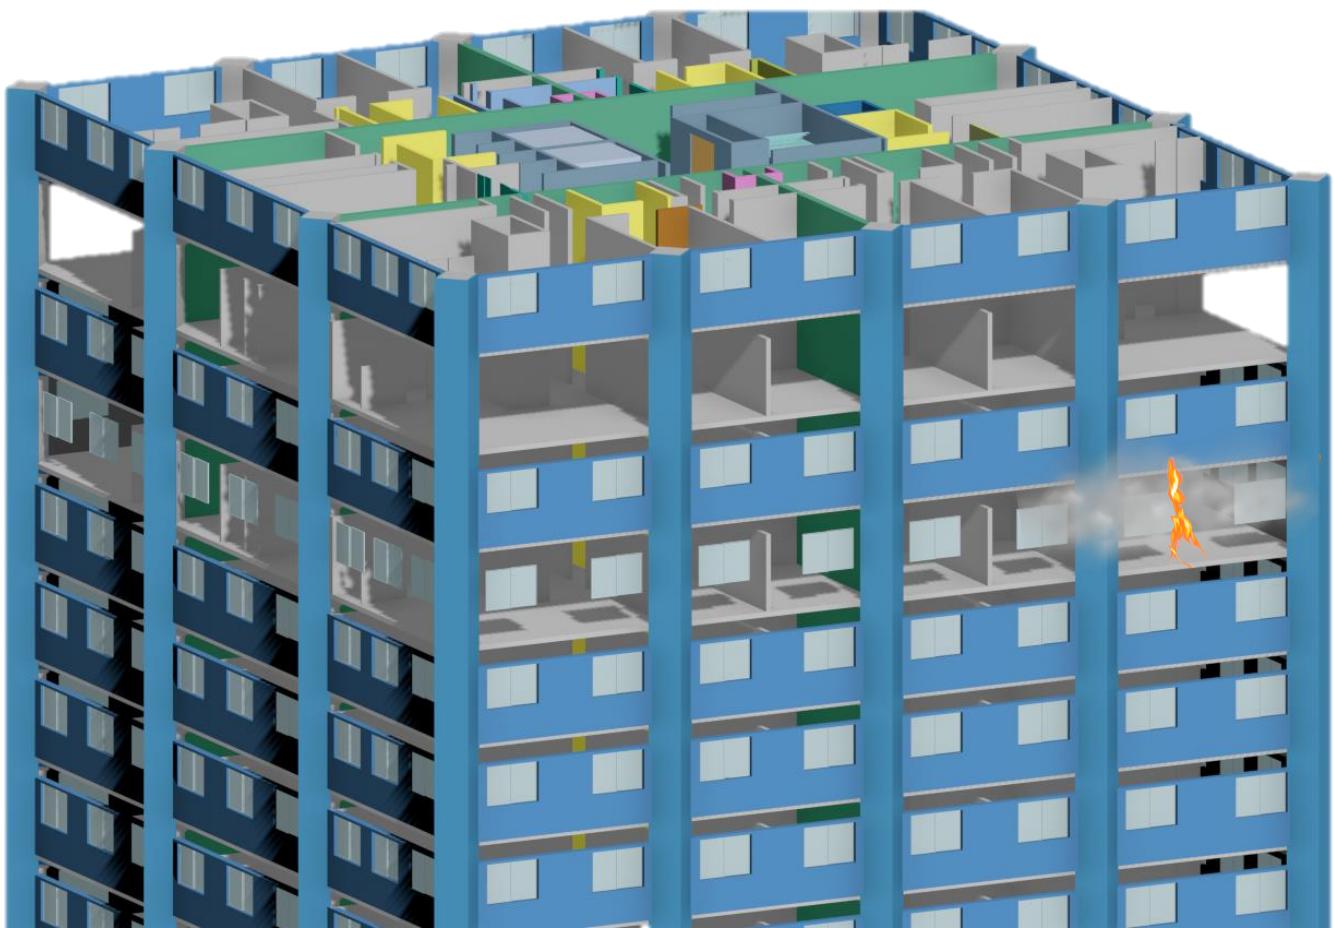
Ignition (0-5 min)

The detectors activate at 60 °C and the alarms activate. Evacuation commences.

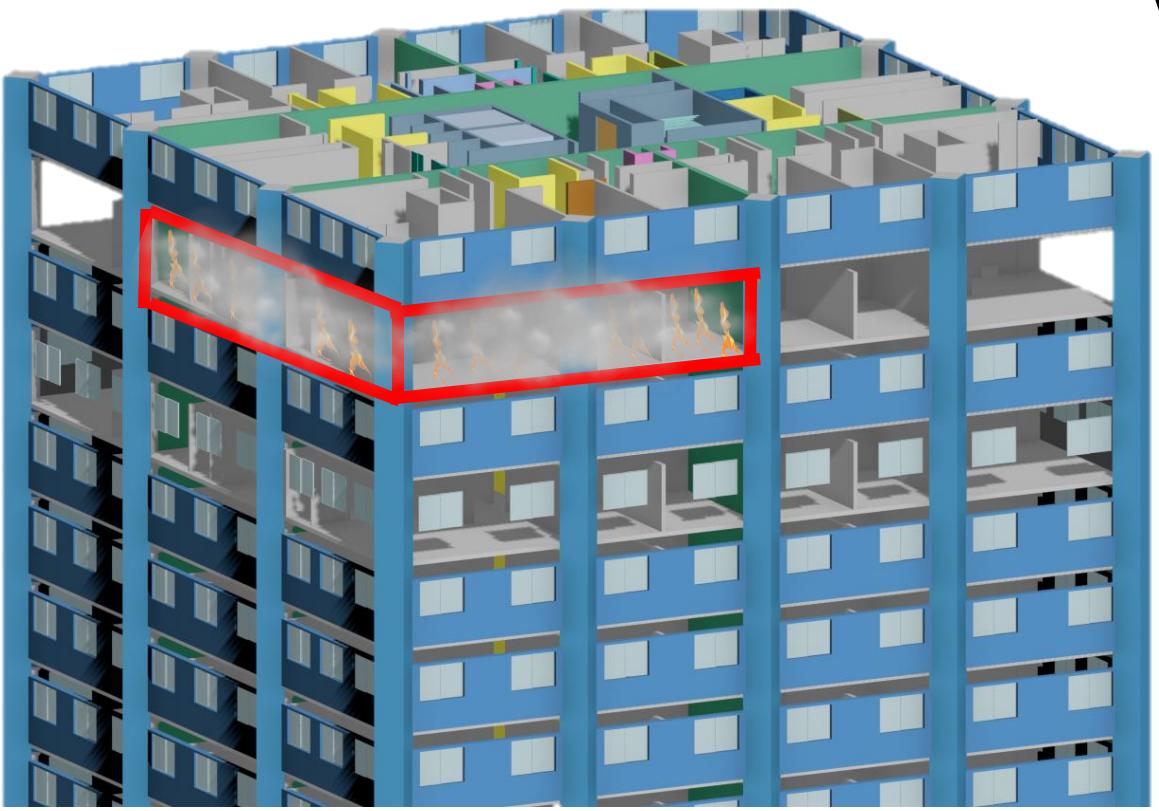
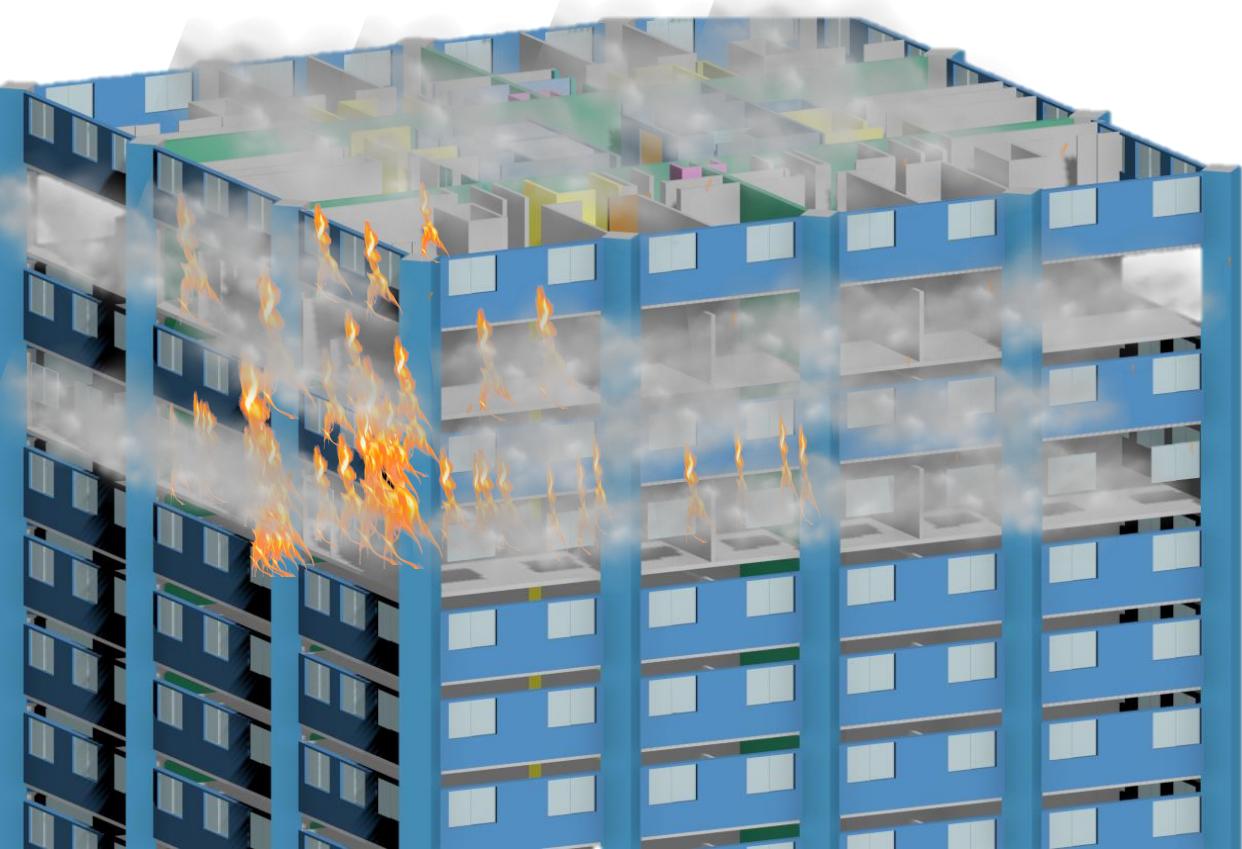
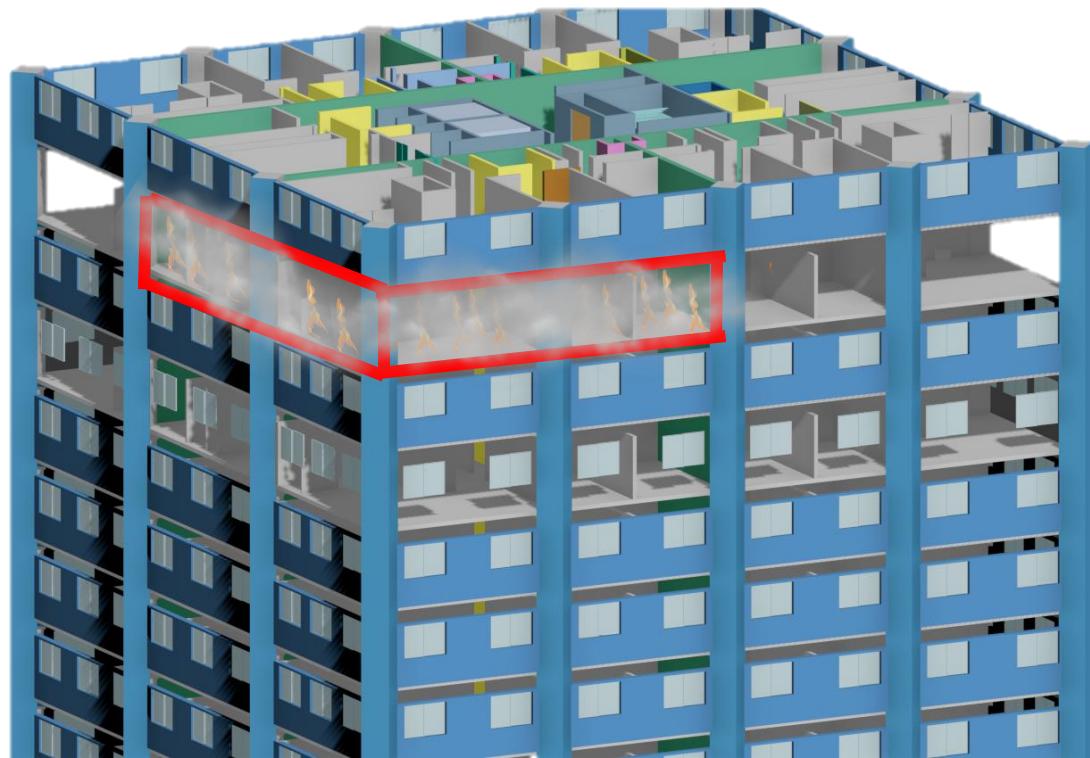
Concept of compartmentation

- Compartmentation should isolate each apartment or designated area – making it as safe as a 2 storey house.
- **This prevents flame spread, and smoke spread.**

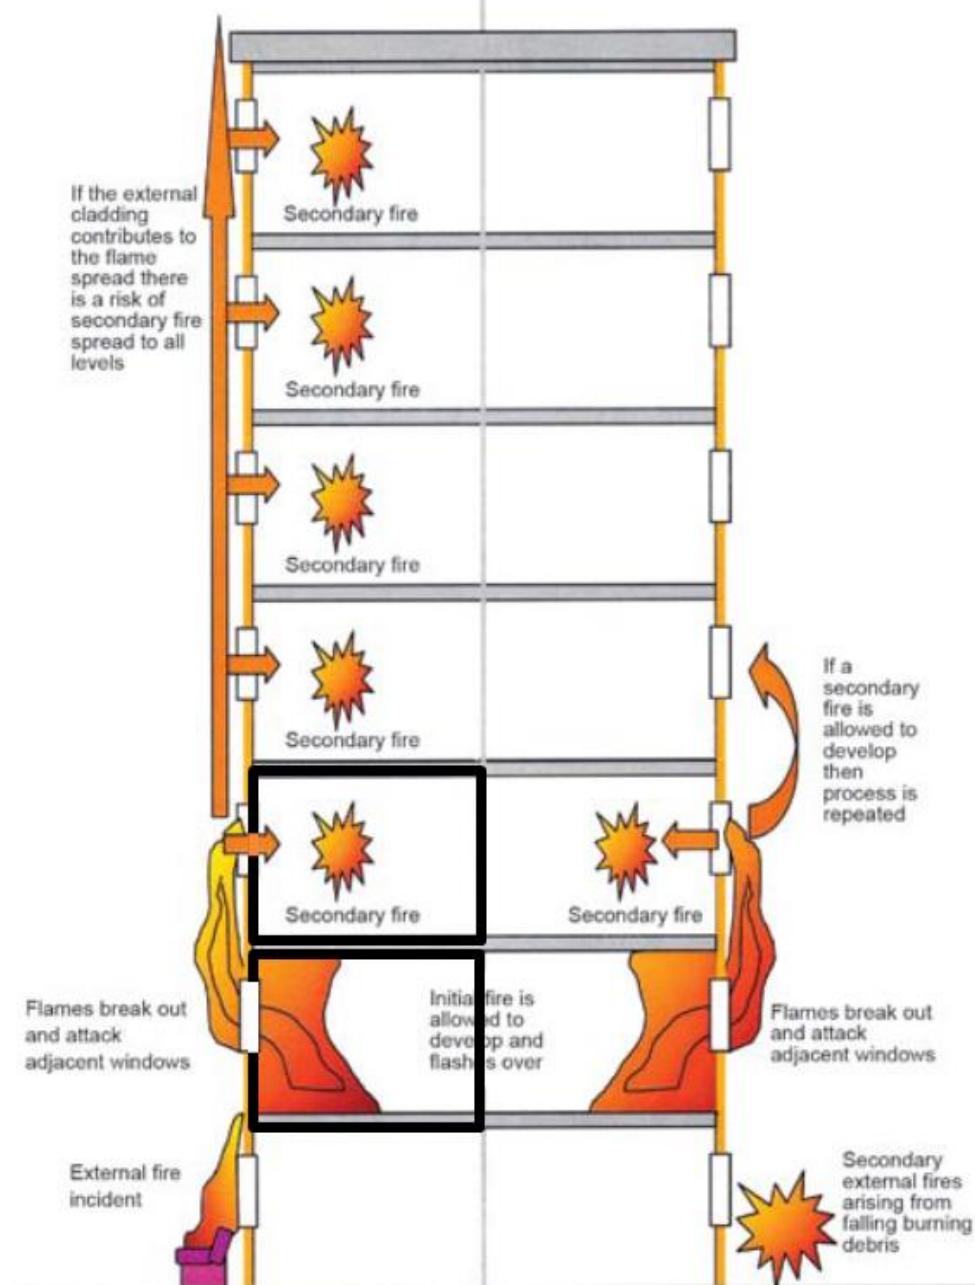
Rapid Fire Spread

Cladding system contributes to flame spread resulting in risk of multiple simultaneous secondary fires

Restricted Fire Spread

Cladding system does not contribute to flame spread. Risk of secondary fires limited

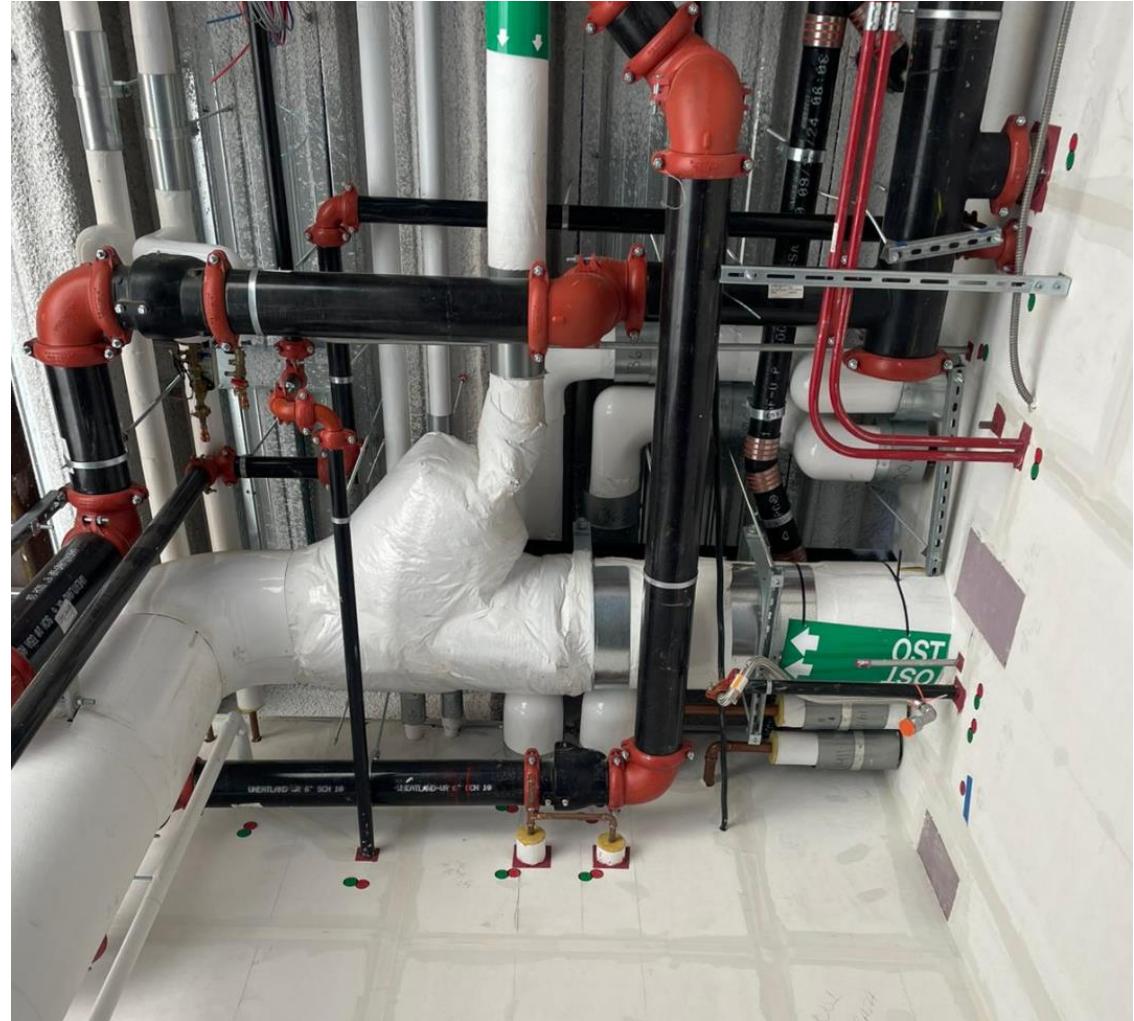
These buildings will have services that will disrupt compartmentation:

- Plumbing pipes through the floor and walls
- Electric cables through walls, floors, ceilings etc..

How do we maintain compartmentation when the wall has holes in for services?

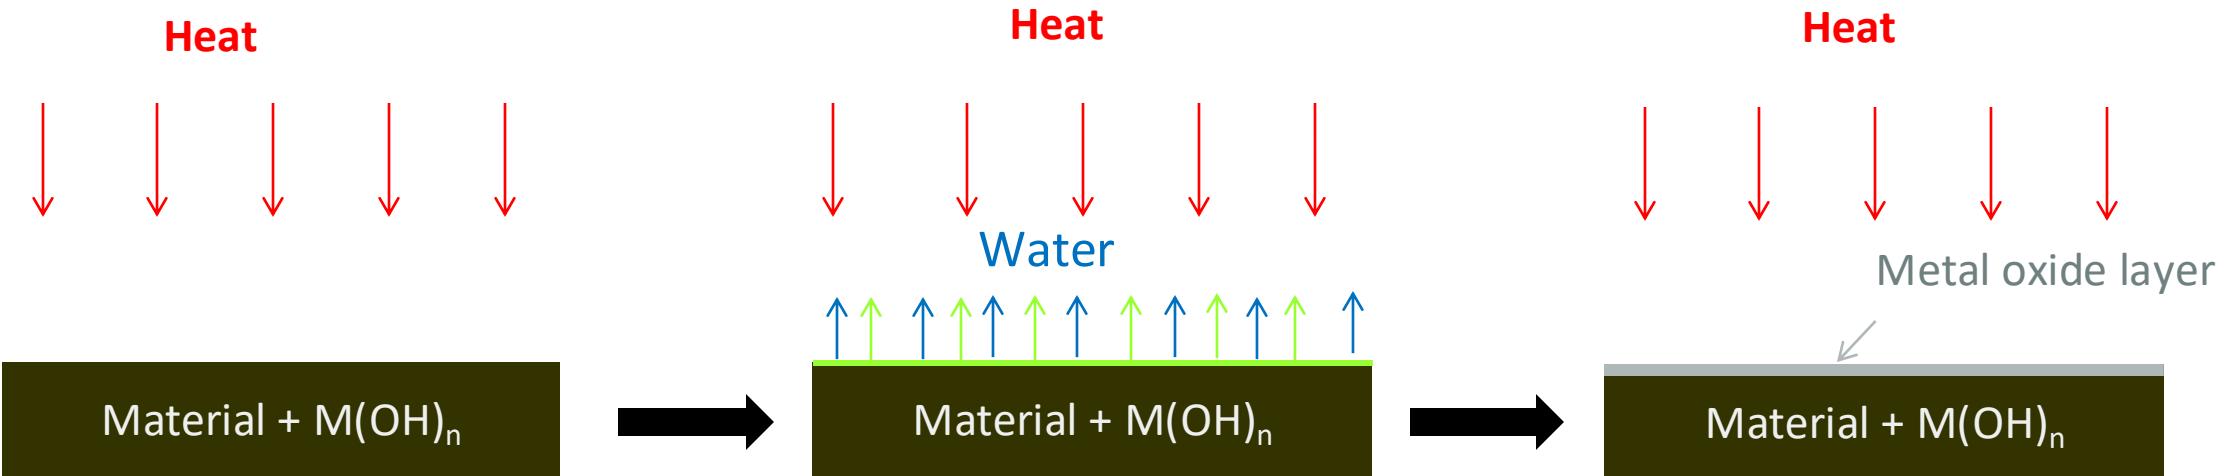
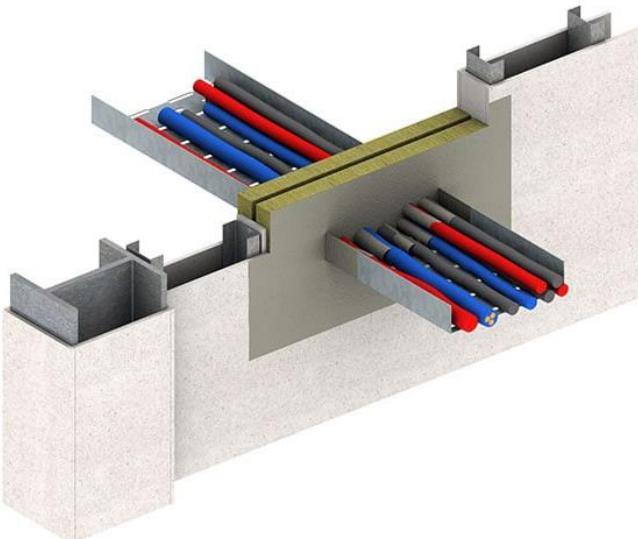
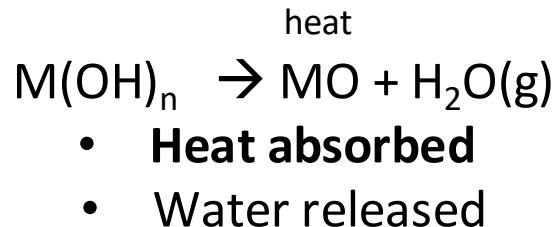
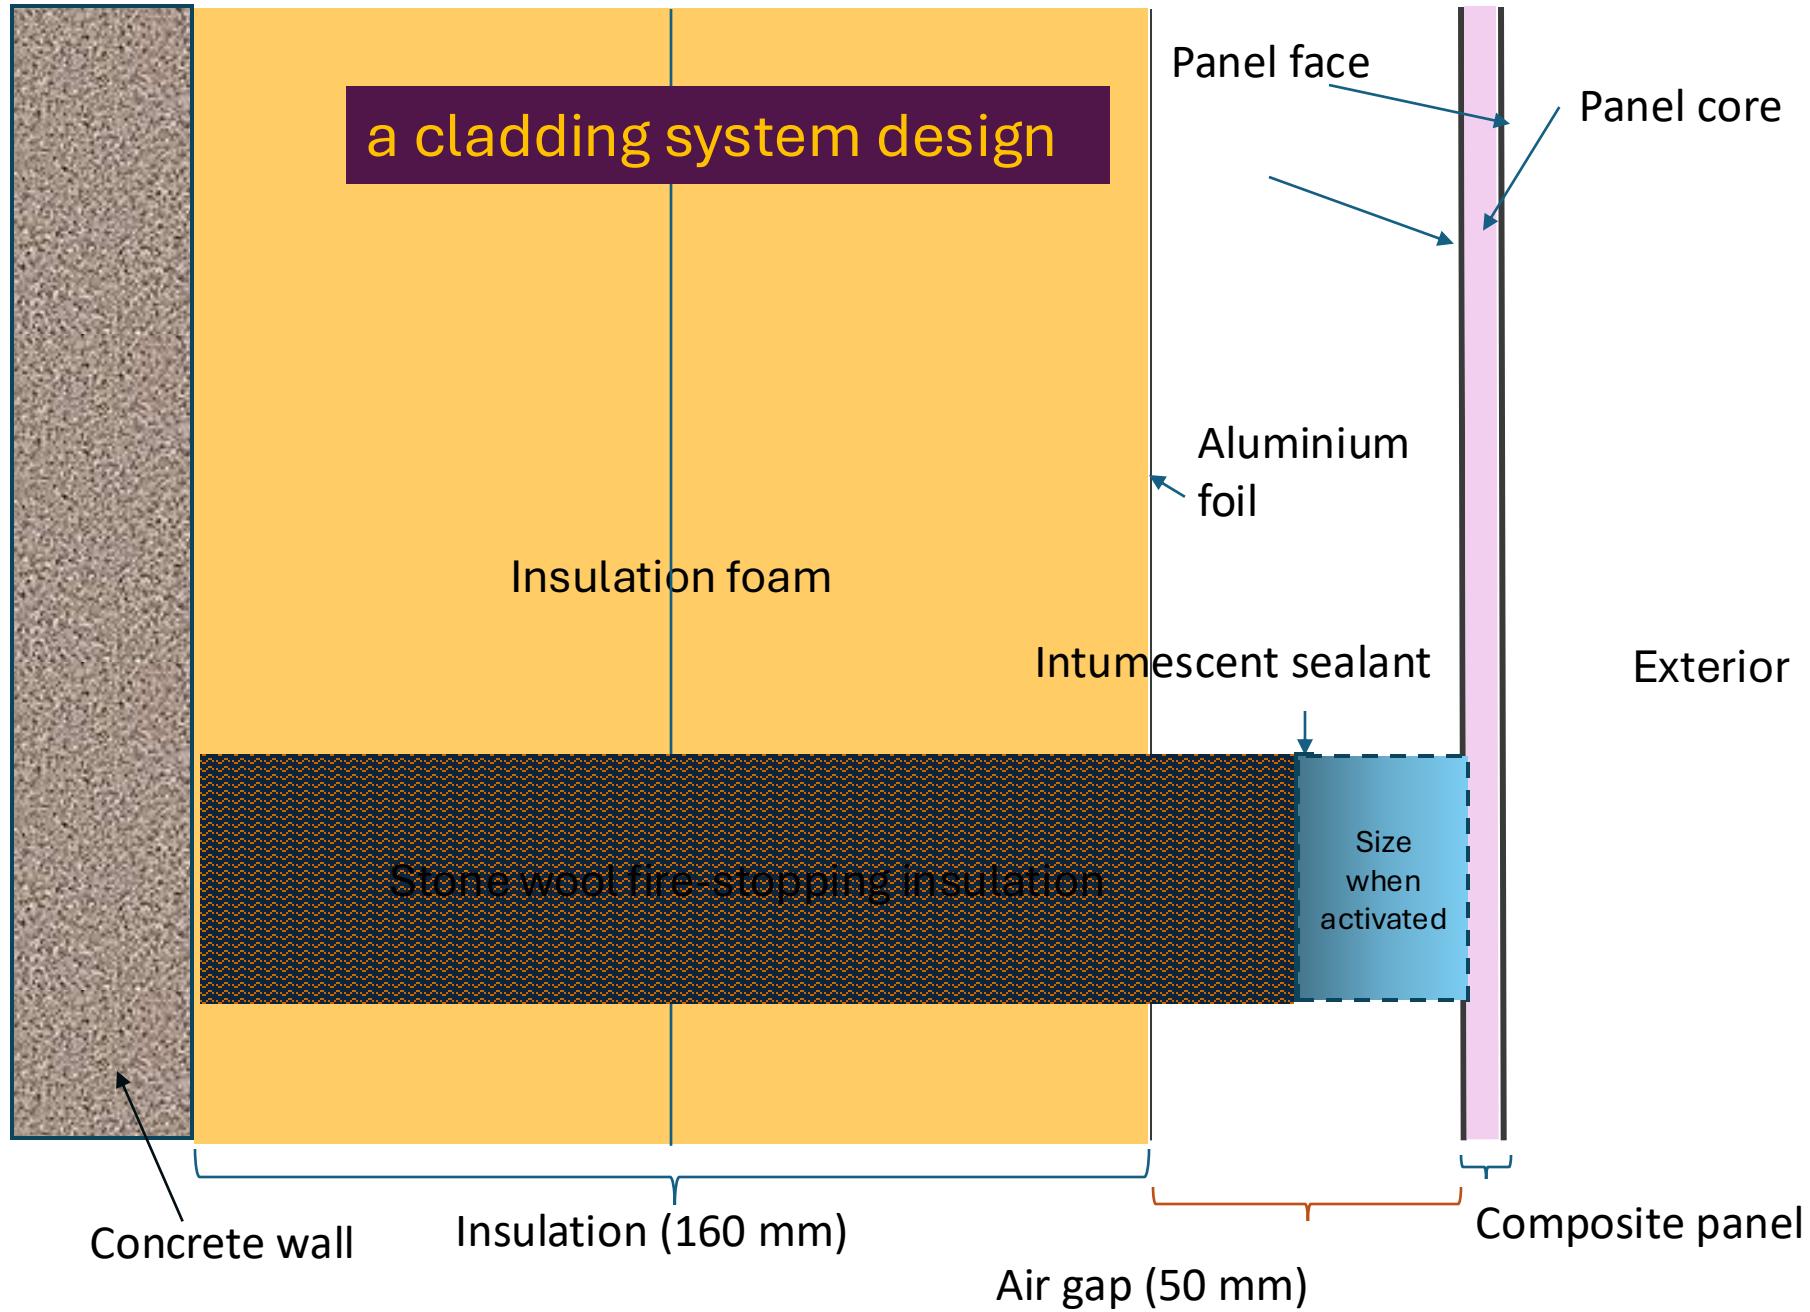
Endothermic materials

(Material decomposes to fuel)

Layer of MO on surface :

- **Radiation shield**
- Continuous barrier to fuel and oxygen

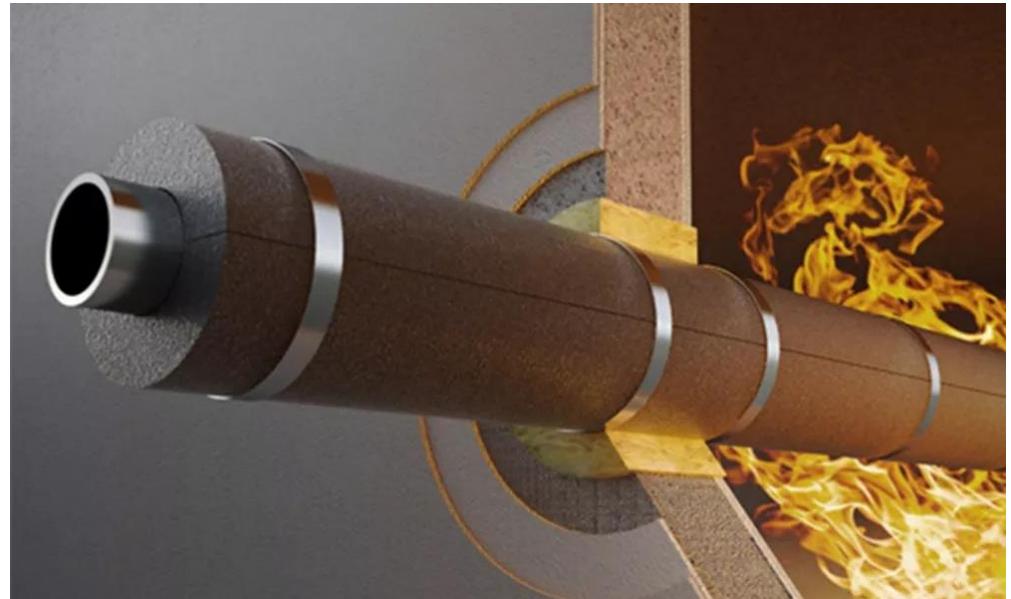
F- rating

- This certifies a firestop's **ability to block flame passage**.
- **This is defined as the Time (in hours) a system prevents flame passage to the unexposed side.**
- Requirements: **Field installs must mirror lab test set up** (e.g., exact fill depth);
- **A 2-hour F means ≥ 2 hours before breakthrough.**
- Chosen to match barrier rating (e.g., 2-hr wall requires 2-hr F)
