The role of Passive Fire Protection

Dr Gabrielle Peck, BSc(Hons), Ph.D., MRSC,
Technical Director

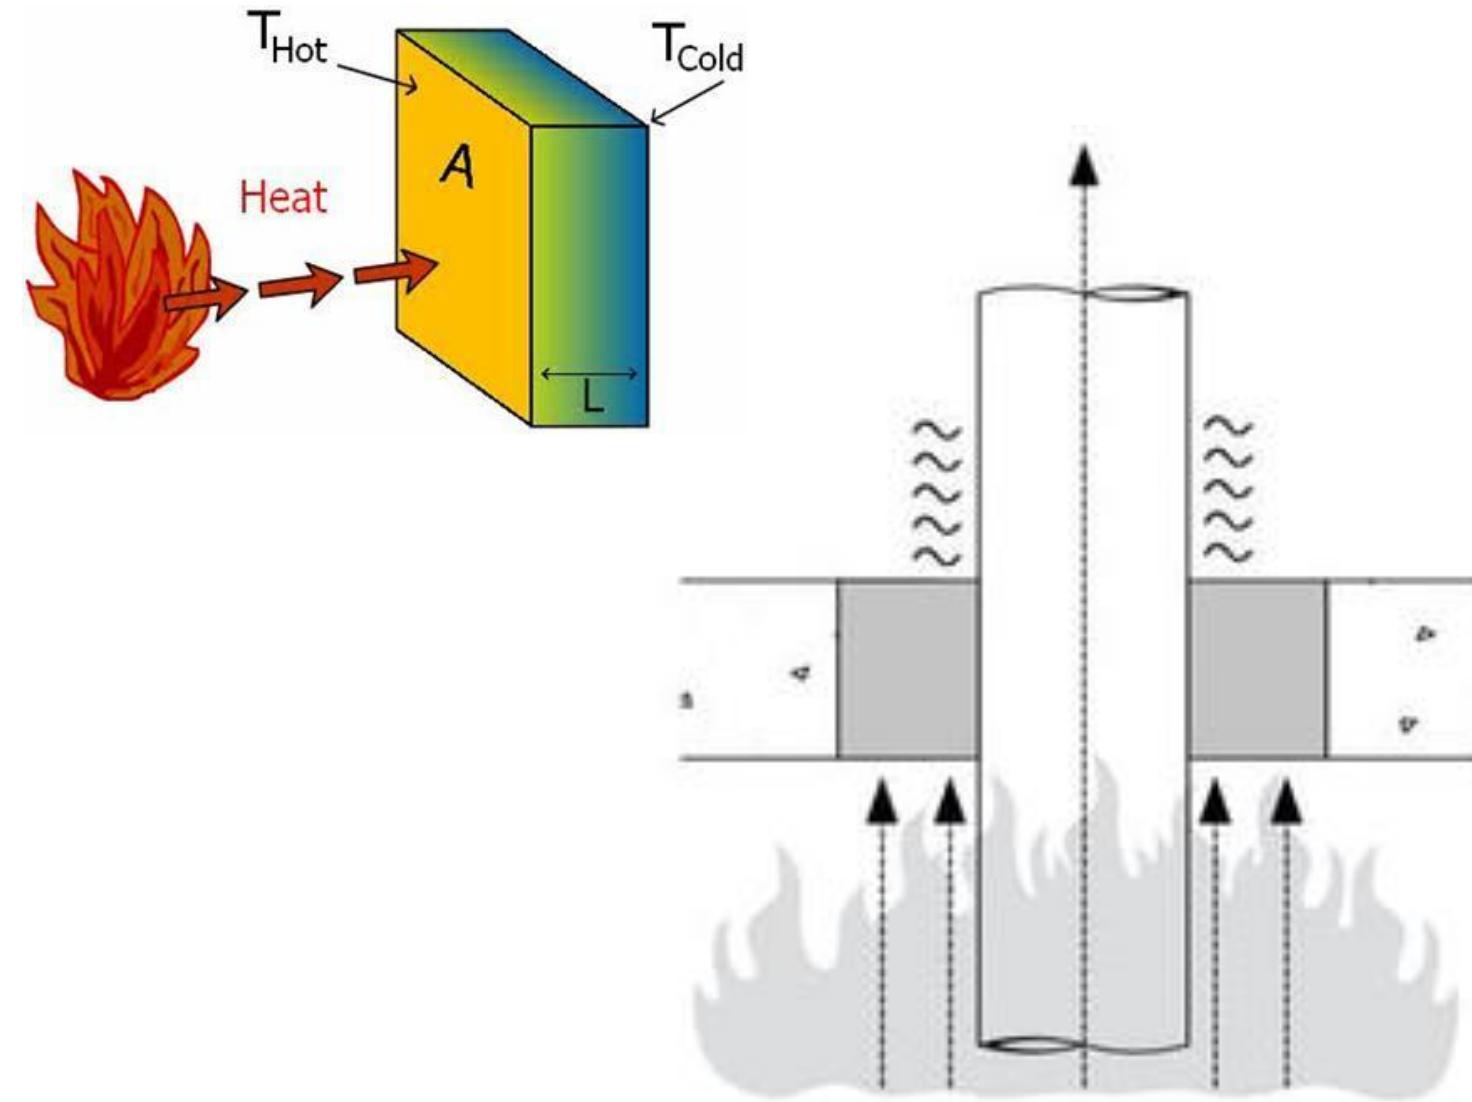
- The time before unexposed side temperature rises 325°F (163°C) above ambient, plus no flame.
- Selected for occupant protection in escape paths (NFPA 101).
- T-Rating limits heat conduction through the firestop, preventing auto-ignition on the unexposed side (e.g., cables melting, sparking secondary fires).

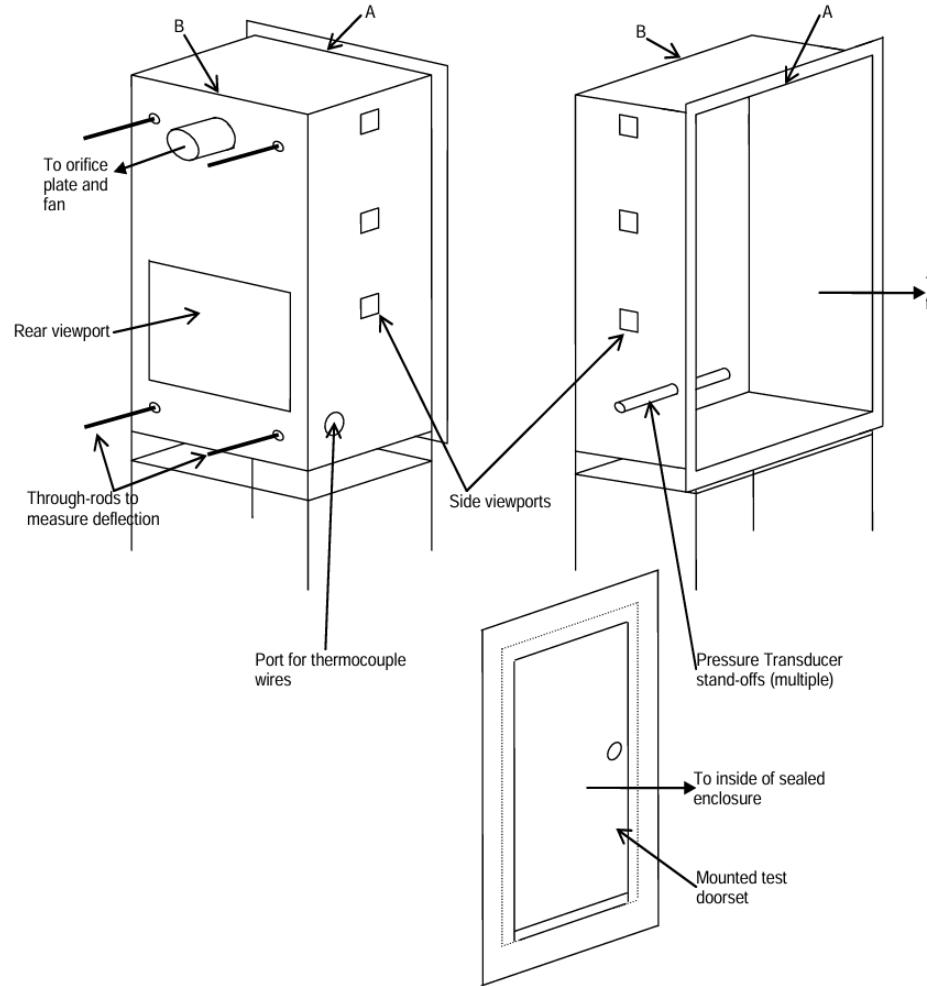
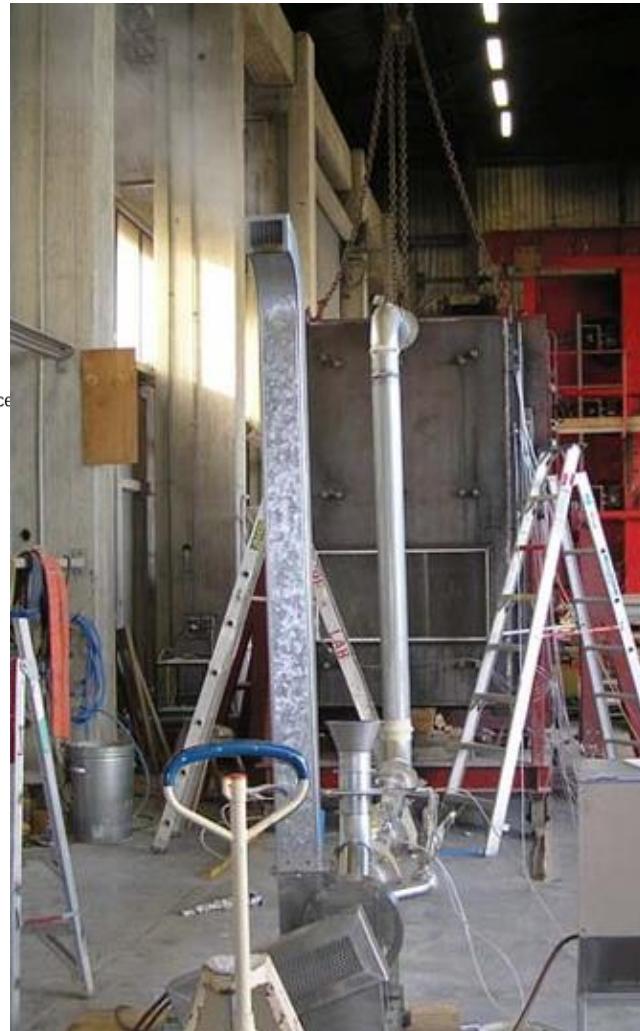
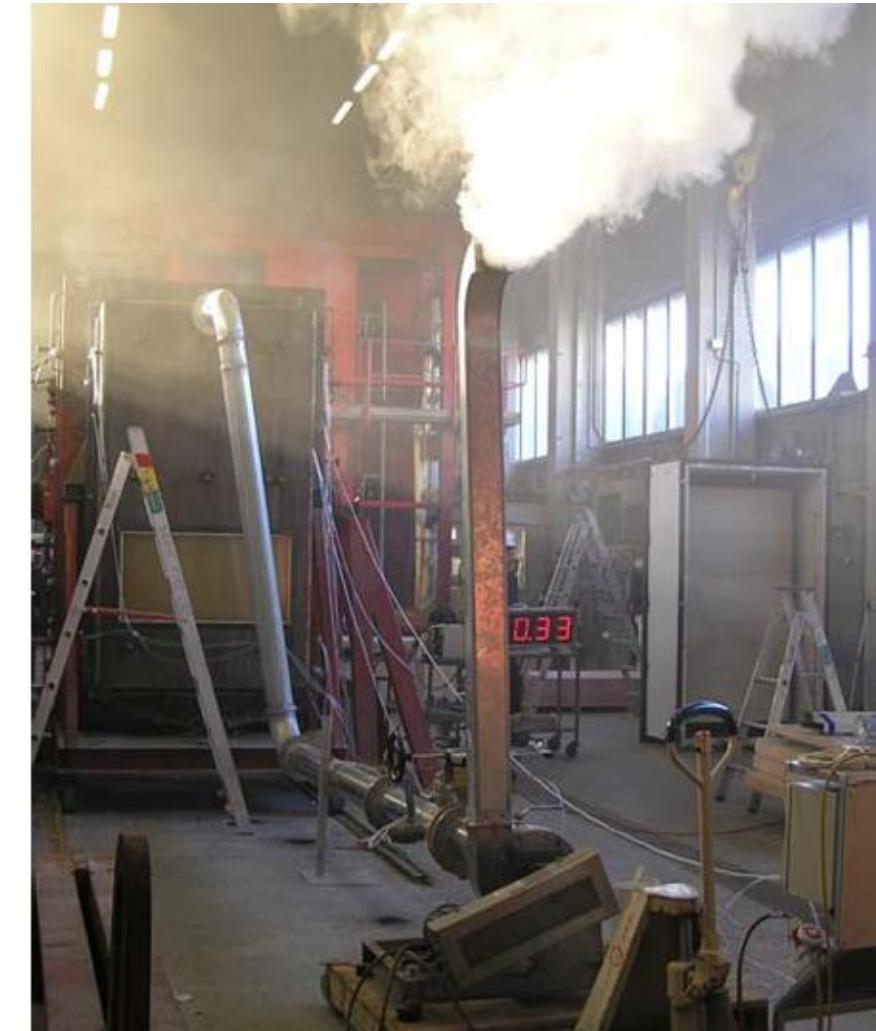
- L-Rating: Air leakage rates for smoke seal assess how much smoke will pass through the system.
- It is determined post-fire via blower door test; required for smoke barriers (NFPA 105).
- L-Rating measures air/smoke leakage
- Even F/T-rated systems leak if unsealed—L ensures tenable air for escape.
- Steps:
 - (1) Fire test first
 - (2) Cool, seal chamber
 - (3) Apply pressure, measure flow.
- UL 1479 Annex
- E/ASTM E814 Annex A

- L-Rating: Air leakage rates for smoke seal

- E/ASTM E814 Annex A

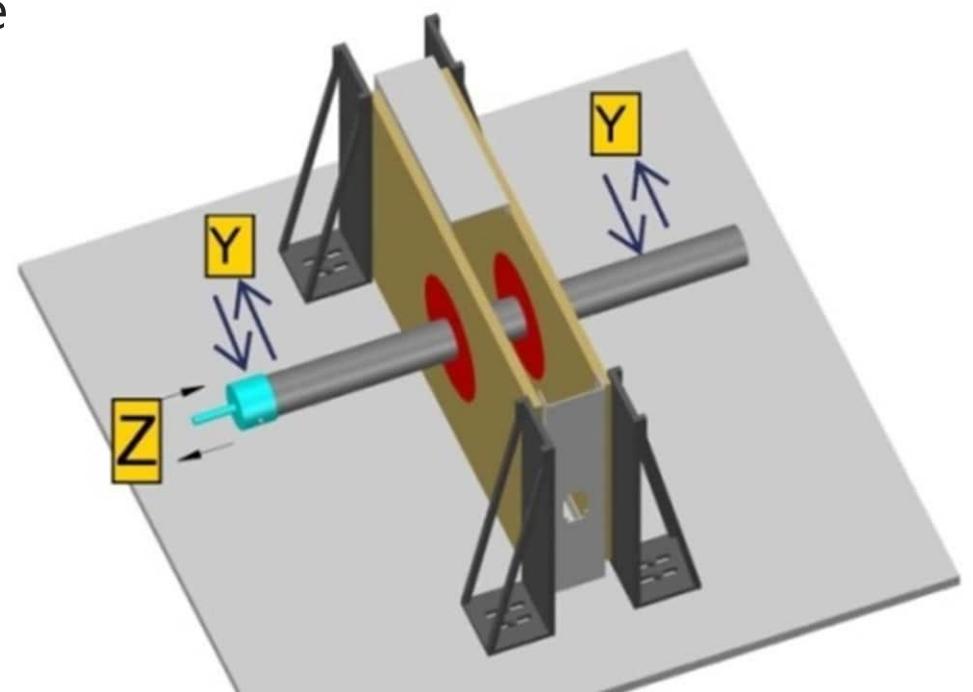
Movement: Maximum displacement (mm) in axial/lateral directions while maintaining integrity.

- Tested under cyclic movement; chosen for seismic/dynamic joints (e.g., IBC Table 715.3).
- Selection depends on hazard (e.g., occupancy, penetration type) and codes; e.g., high-rises mandate 2-3 hr F/T.
- M-Rating assesses firestop resilience to building movement (thermal expansion, seismic), preventing cracks that breach seals.
- M=25% means handles 25% annular space shift.

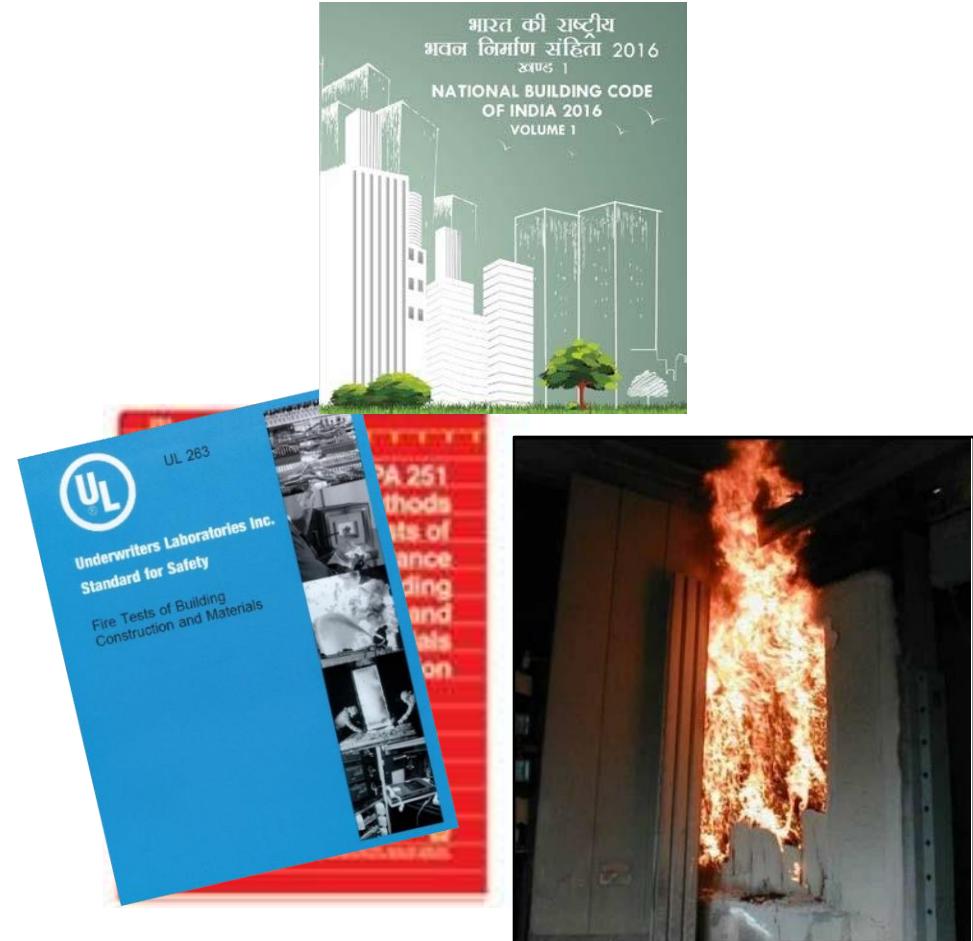
UL Image

Standard Tests Establish Fire-Resistance

- USA, and North America
 - ASTM E119
 - UL 263
- Canada
 - ULC-S101
- Euro
- ISO 834
 - BS 476/EN 1363

Time Temperature Curve

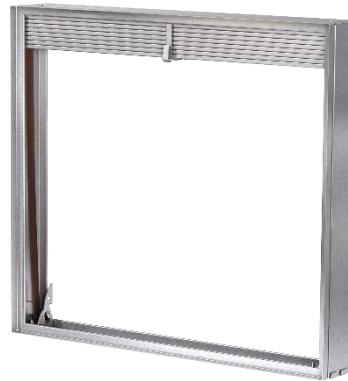
Curtain Fire
Damper

“A device, installed in an air distribution system, designed to close automatically upon detection of heat, to interrupt migratory airflow, and to **restrict the passage of flame**.” (NFPA 80) –IBC 2024 Section 717

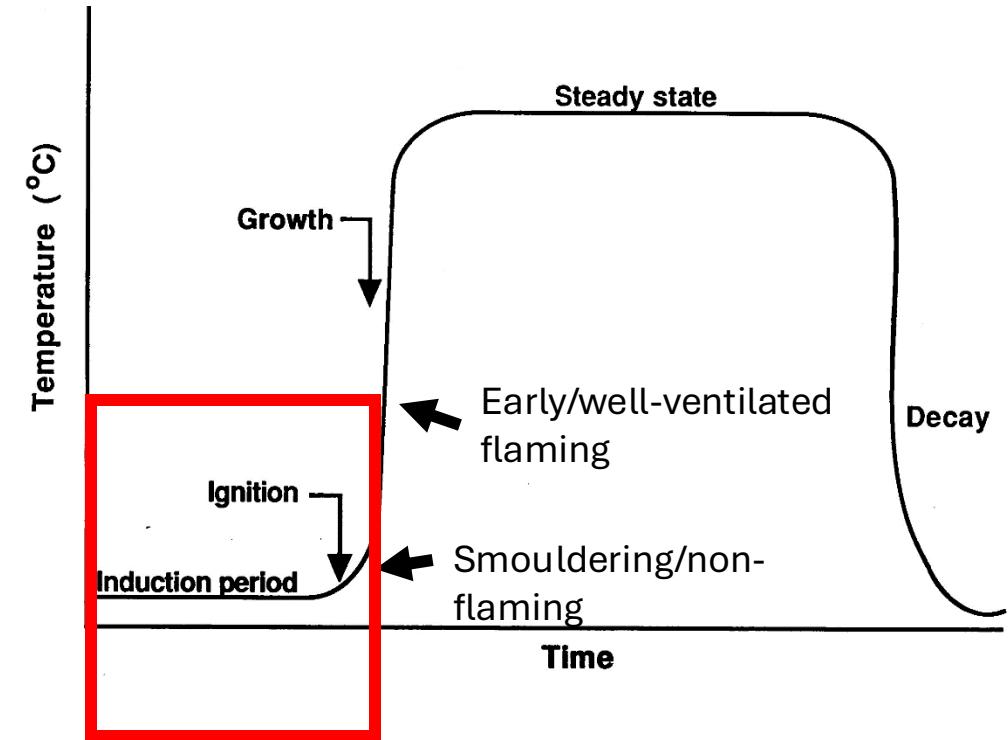
C-AJ-1291: During a fire

- **Stage 2: Growth (5-15 min)**
- Heat increases (approx. 2 MW HRR).
- The mineral wool's ceramic matrix dehydrates endothermically, absorbing heat and releasing water vapor, insulating the pipe (surface typically below 400°C or 752°F).
- No flame passage occurs, maintaining the F-rating.
- The intumescent sealant begins to char, blocking heat and smoke convection.
- The char layer enhances the system's structural stability.

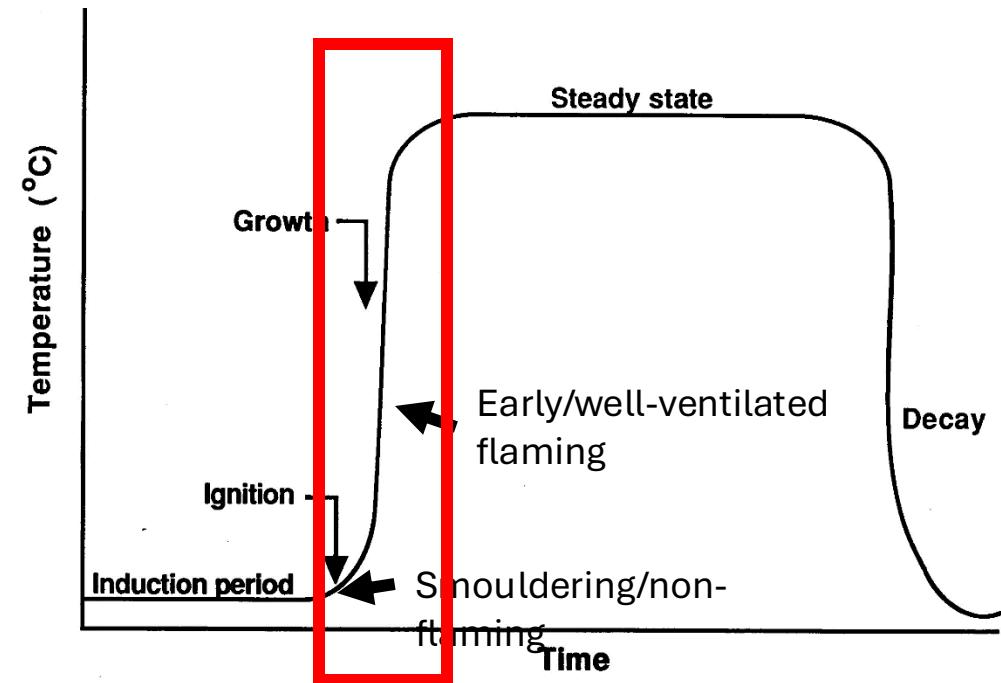
C-AJ-1291: During a fire

- **Stage 3: Flashover (15-20 min)**
- As temperatures rise, the mineral wool forms an insulating crust (alumina-silica sinters, thermal conductivity <0.08 W/m·K).
- The T-rating holds, with the unexposed side below 181°C (358°F).
- System integrity is maintained: no cracks, minimal smoke leakage (L-rating compliant).

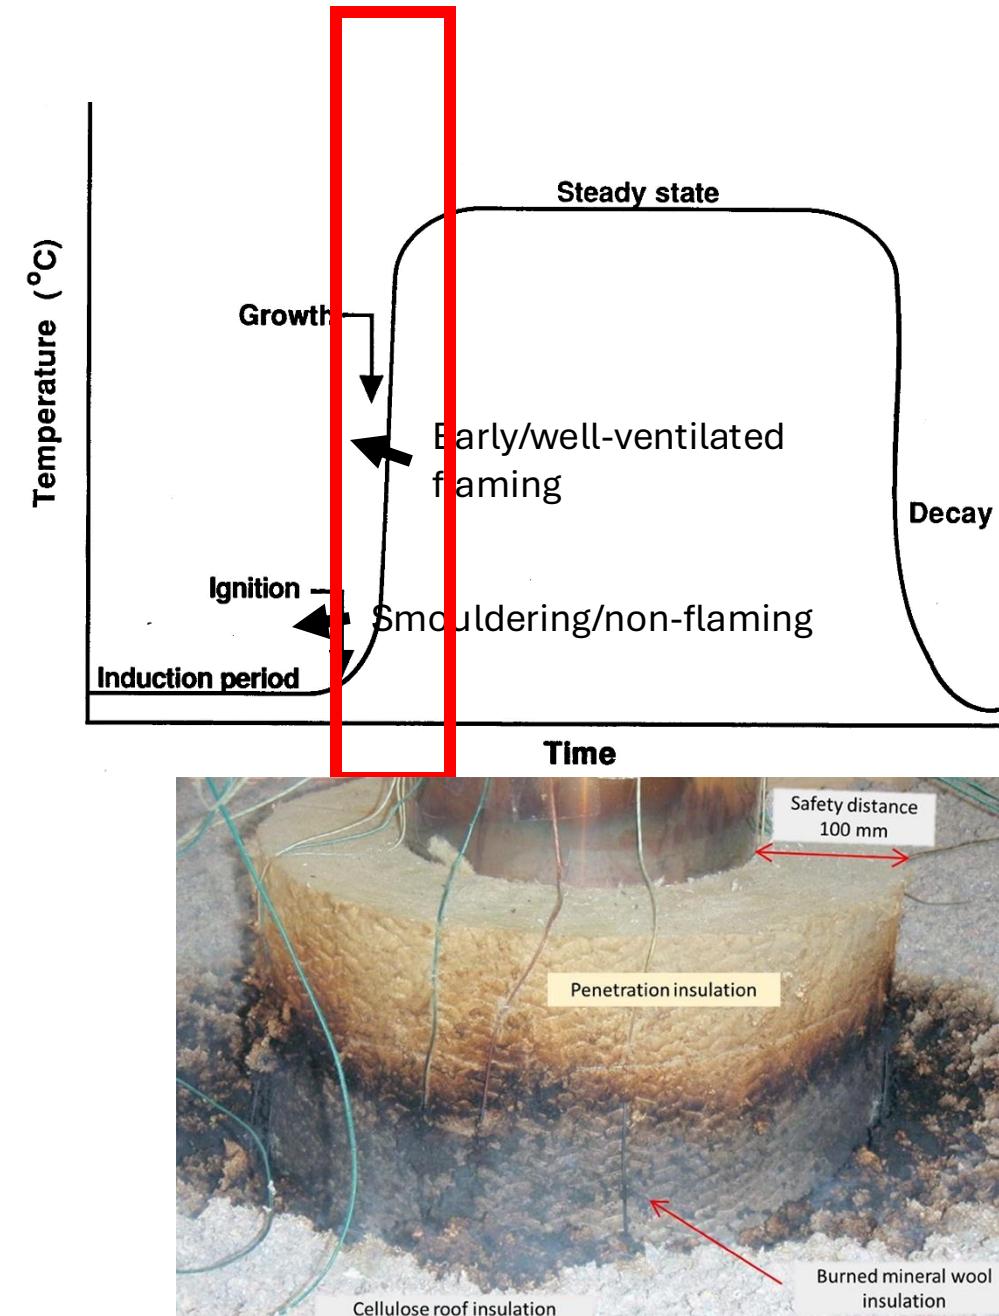
C-AJ-1291: During a fire

- **Stage 4: Full Development (20-120 min)**
- Under sustained exposure, the char layer from the intumescent sealant and sintered mineral wool prevents autoignition.
- Smoke leakage remains minimal, ensuring safe egress and maintaining the 2-hour F/T ratings.

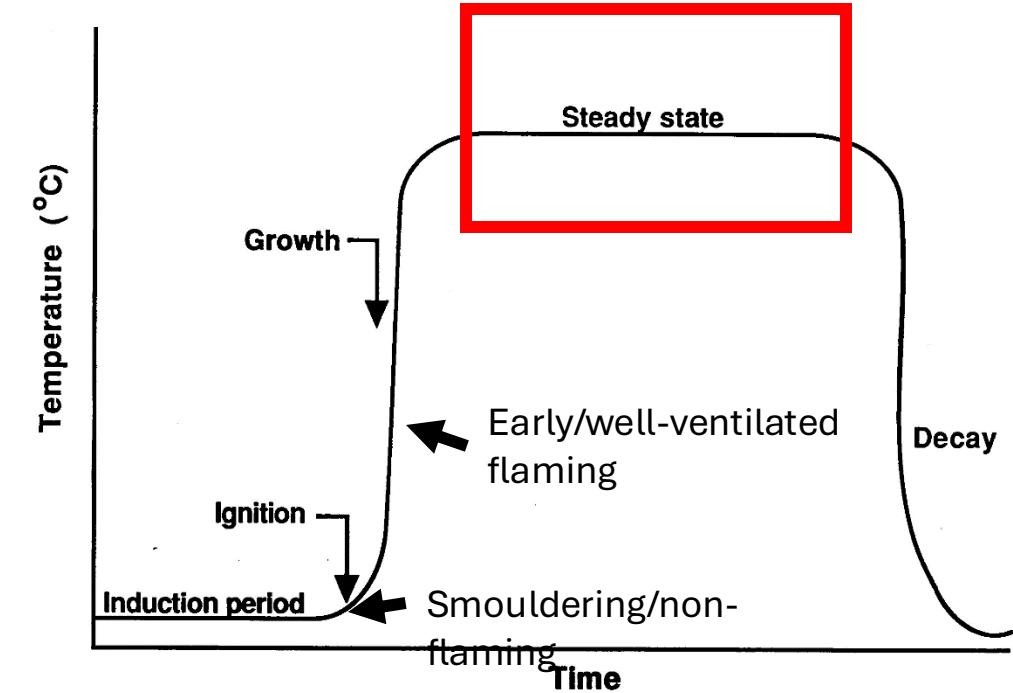
C-AJ-1291: During a fire

During active firefighting, egress and decay

- ✓ The system does not erode
- ✓ 2-hr containment achieved
- ✓ Safe means of egress maintained

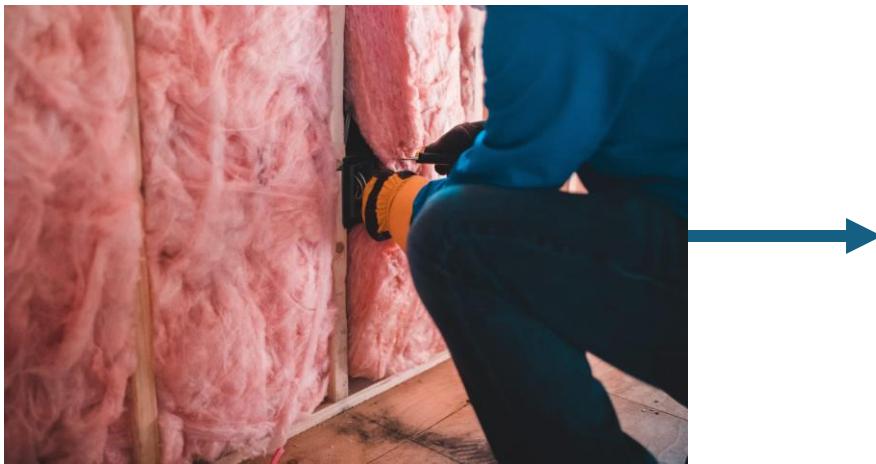
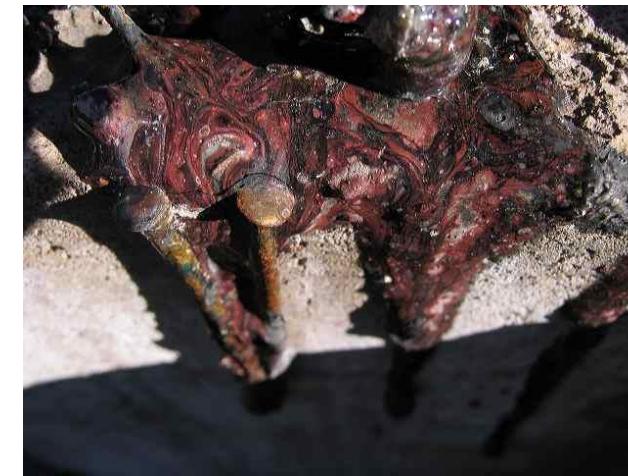
C-AJ-1291: Substitute rockwool with fibreglass

- **Substitute Fiberglass for Mineral Wool**
- Replace mineral wool with E-glass fiberglass insulation (**melting** ~800°C or 1472°F).
- It softens at approximately 600°C (1112°F) and melts into a viscous flow at ~800°C (1472°F).
- **fiberglass does not char**; it undergoes melting and viscous deformation under fire exposure.

- Initial insulation holds as temperatures are low, but as heat rises, fiberglass fibres begin to soften (softening point $\sim 600^\circ\text{C}$).
- Minor smoke leakage begins as any organic binders decompose (if present) and fibres start to sink slightly, but the intumescent sealant holds initially (T -rise $< 140^\circ\text{C}$ on unexposed side).

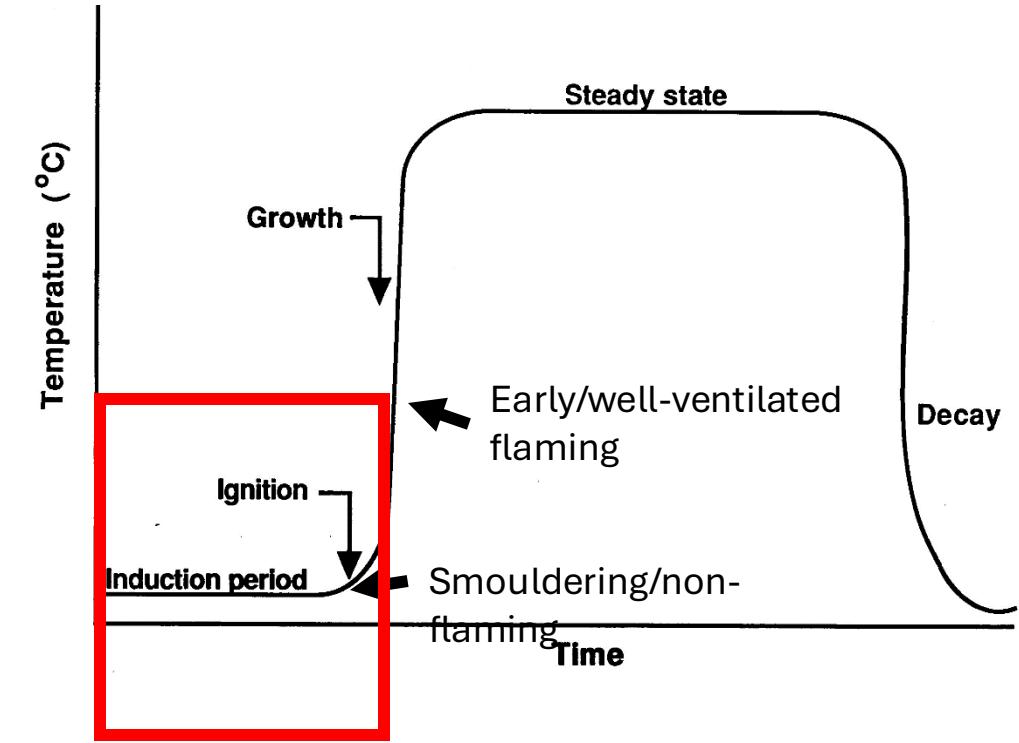
C-AJ-1291: Substitute rockwool with fibreglass

- **Stage 2: Growth (5-15 min)**
- Heat intensifies (~700-780°C), causing the fiberglass to soften further and begin melting into glassy droplets.
- Voids form as the material slumps and collapses, allowing convective heat flow.
- Flame starts to penetrate the annular space, compromising the barrier.
- The metal pipe temperature rises rapidly to over 550°C (1022°F).
- The intumescent sealant begins to expand and char, but gaps from melted fiberglass reduce effectiveness.

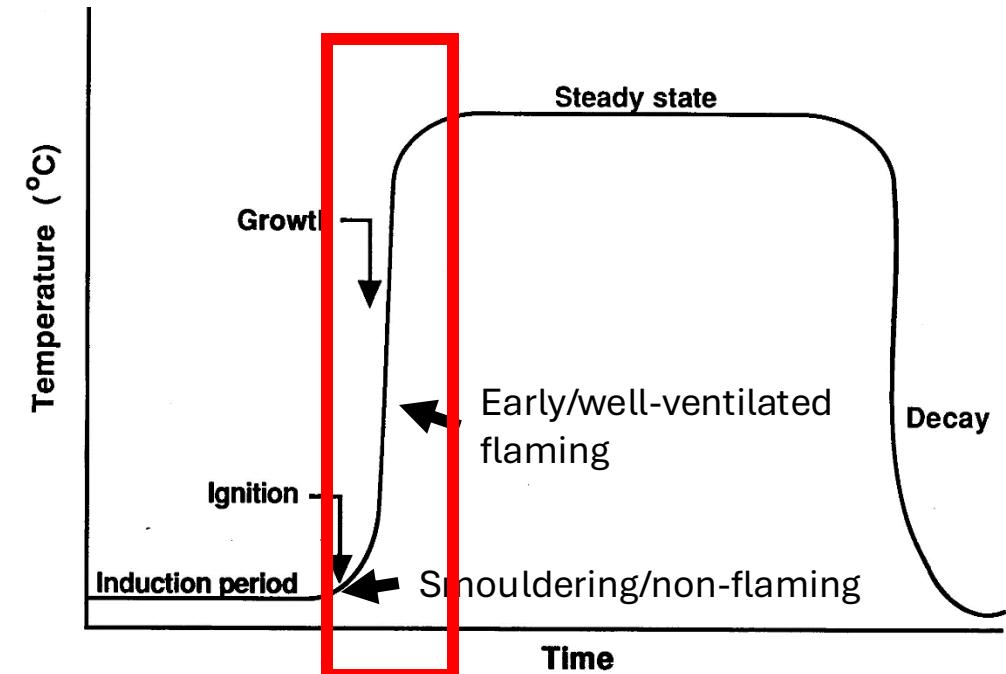
C-AJ-1291: Substitute rockwool with fibreglass

- **Stage 3: Flashover (15-20 min)**
- Temperature rise on unexposed side exceeds 180°C (325°F) in under 10 min, failing T-rating.
- F-rating fails due to through-flame passage as melted fiberglass creates openings.
- Smoke leakage surges with potential irritant gases from binder decomposition.

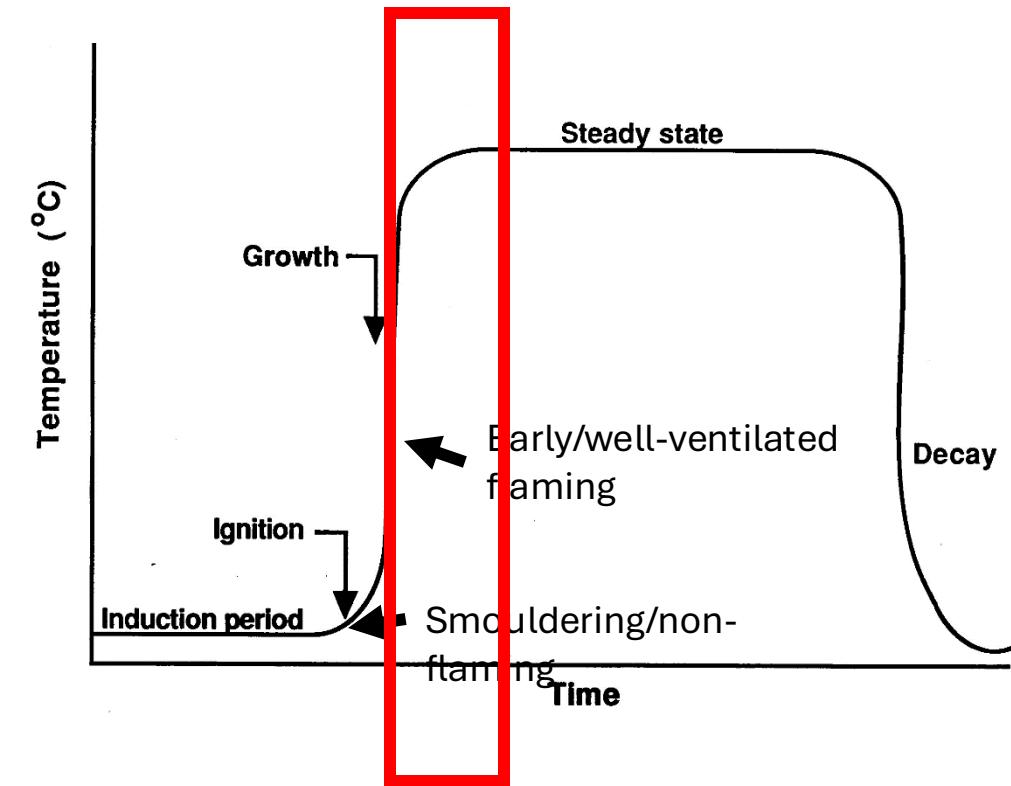
C-AJ-1291: Substitute rockwool with fibreglass

Stage 4: Full Development (20-120 min)

- Cascade failure ensues as molten fiberglass flows, exposing more areas.
- Molten glass drips may not ignite adjacent combustibles directly (as glass is non-combustible), but heat transfer accelerates fire spread.
- The unexposed side experiences excessive heat, compromising compartmentation (sealant char may hold partially, but overall failure).

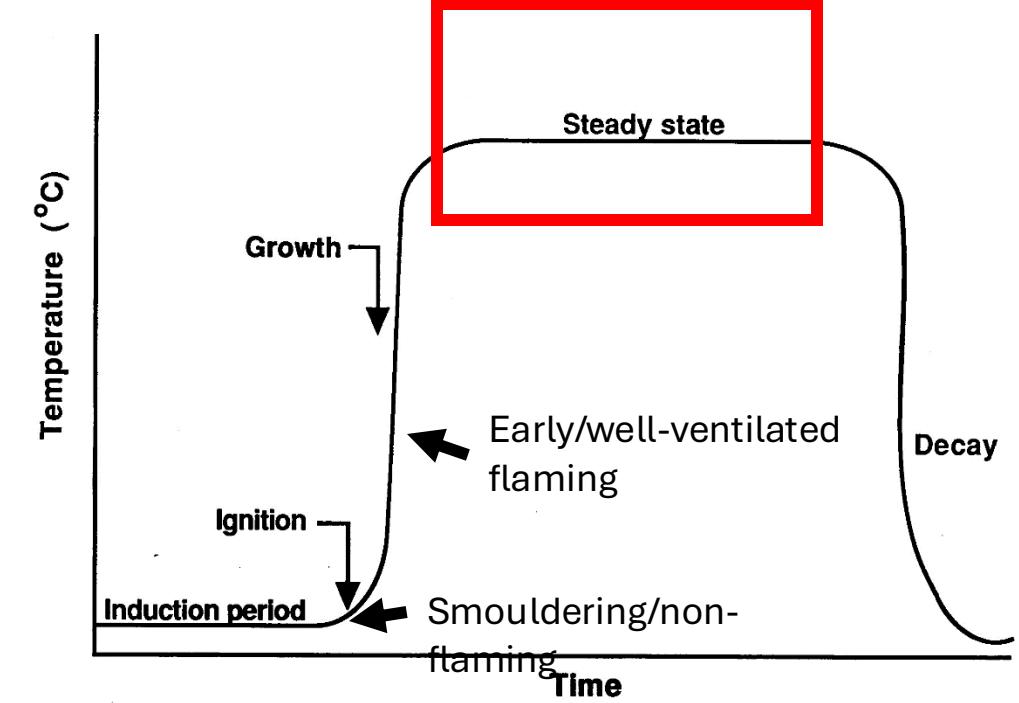
C-AJ-1291: Substitute rockwool with fibreglass

- Material selection must match what has been tested.
- Thermal/chemical profiles for penetrant-substrate vary;
 - fiberglass is unsuitable for this firestop application.

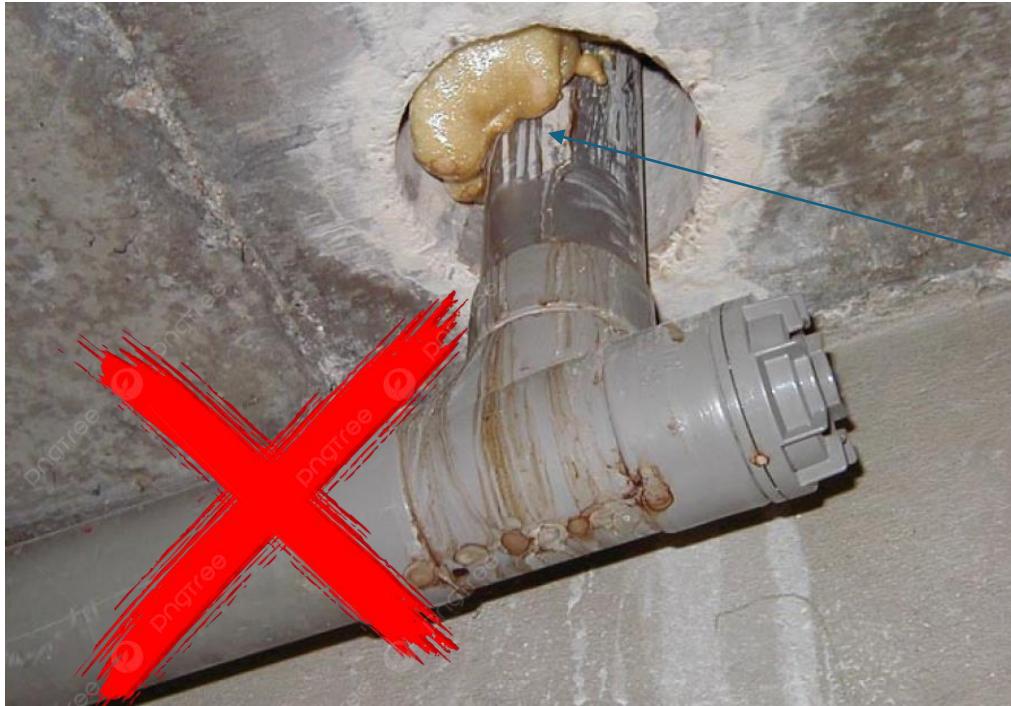
Combustible foam- this will not protect the penetration.

This will generate Hydrogen Cyanide on burning. This will make the problem WORSE.

HCN causes rapid incapacitation & death on inhalation

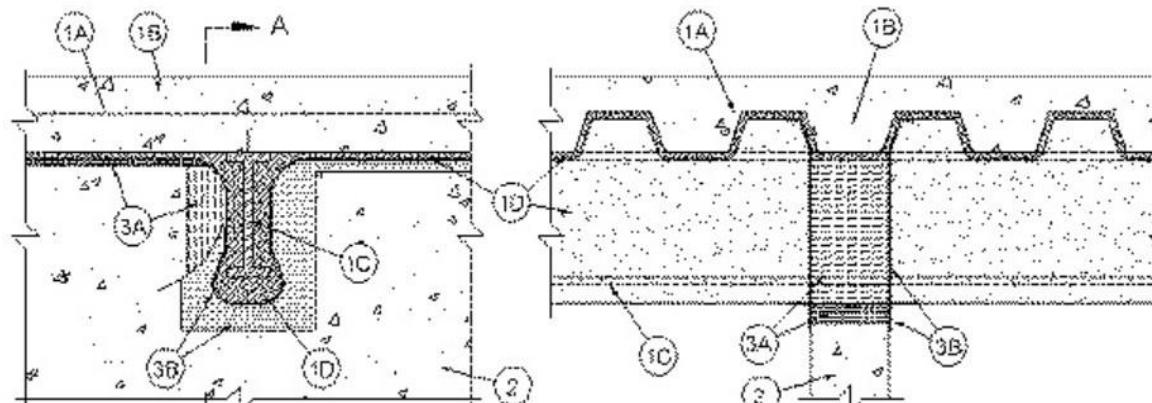
UL Solutions Image / Text HW-D0300 - Rectorseal

L Rating At Ambient - Less Than 1 CFM/Lin Ft

L Rating At 400 F - Less Than 1 CFM/Lin Ft

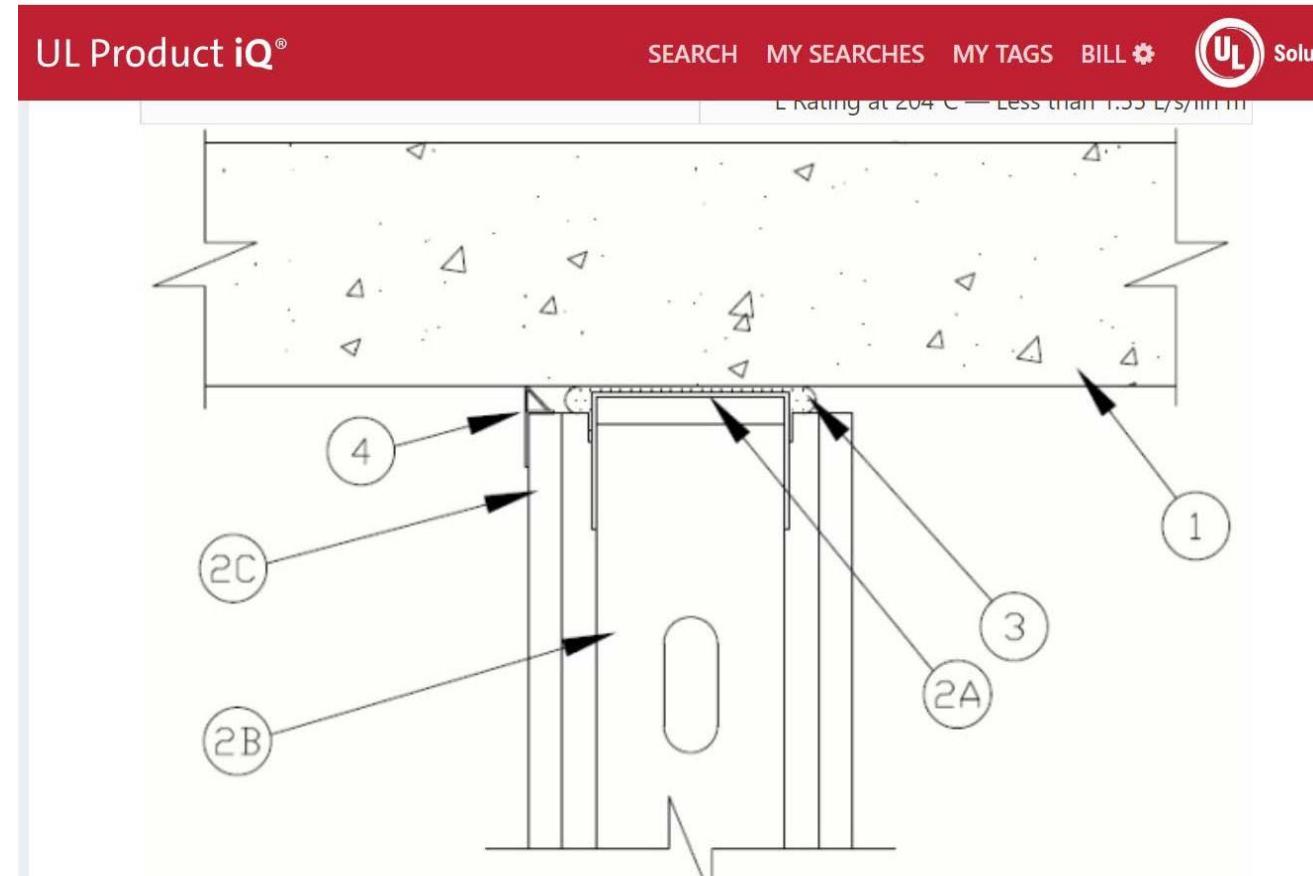
UL Solutions Image

Joints and Voids

Head-of-Wall – Intumescent Strips

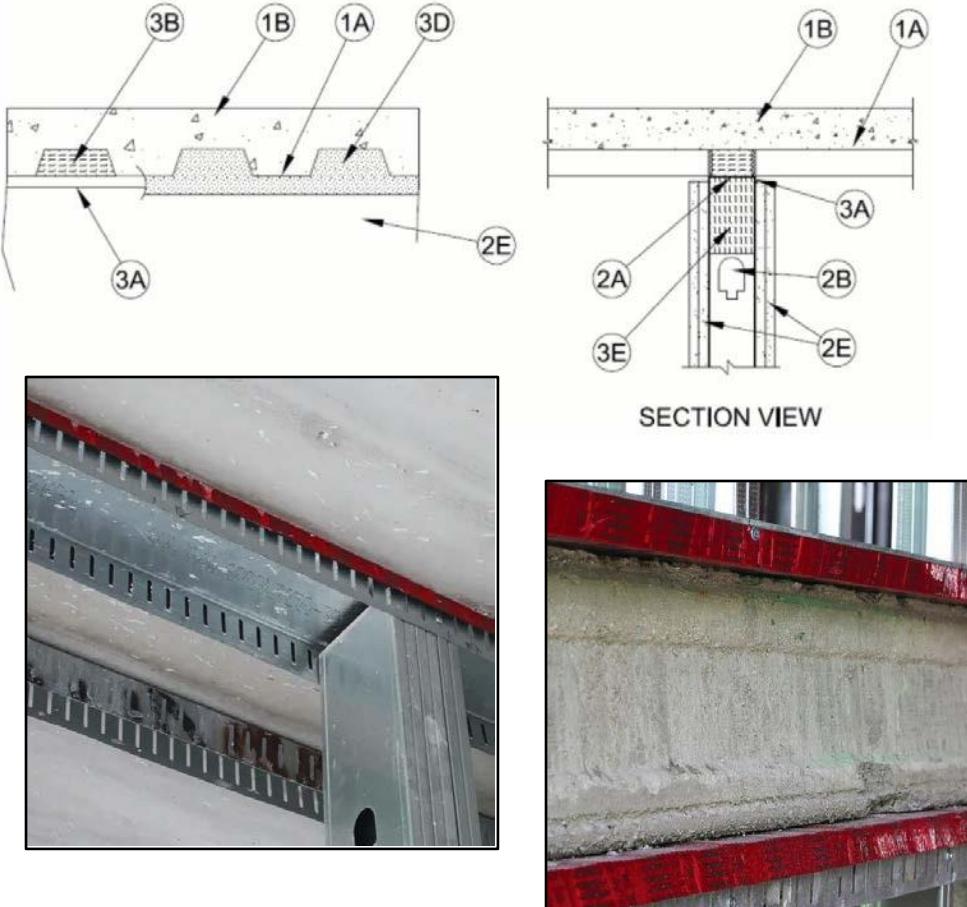
Joints and Voids

Head-of-Wall – Intumescent Strips

3. Joint System — Max separation between bottom plane of the floor or roof and top of gypsum board is 1 in. (25 mm). The joint system is designed to accommodate a max 100 percent compression or extension from its installed width. The joint system consists of the following:

A. Fill, Void or Cavity Material* — Factory-supplied intumescent gasket installed and nominally centered over the ceiling runner (Item 2A, 2A1, 2A2, 2A3) prior to attachment to underside of floor or roof assembly. Gypsum wallboard layers to be installed on both sides of the wall maintaining a minimum 1/8 in. (3 mm) overlap over the intumescent gasket at time of installation.

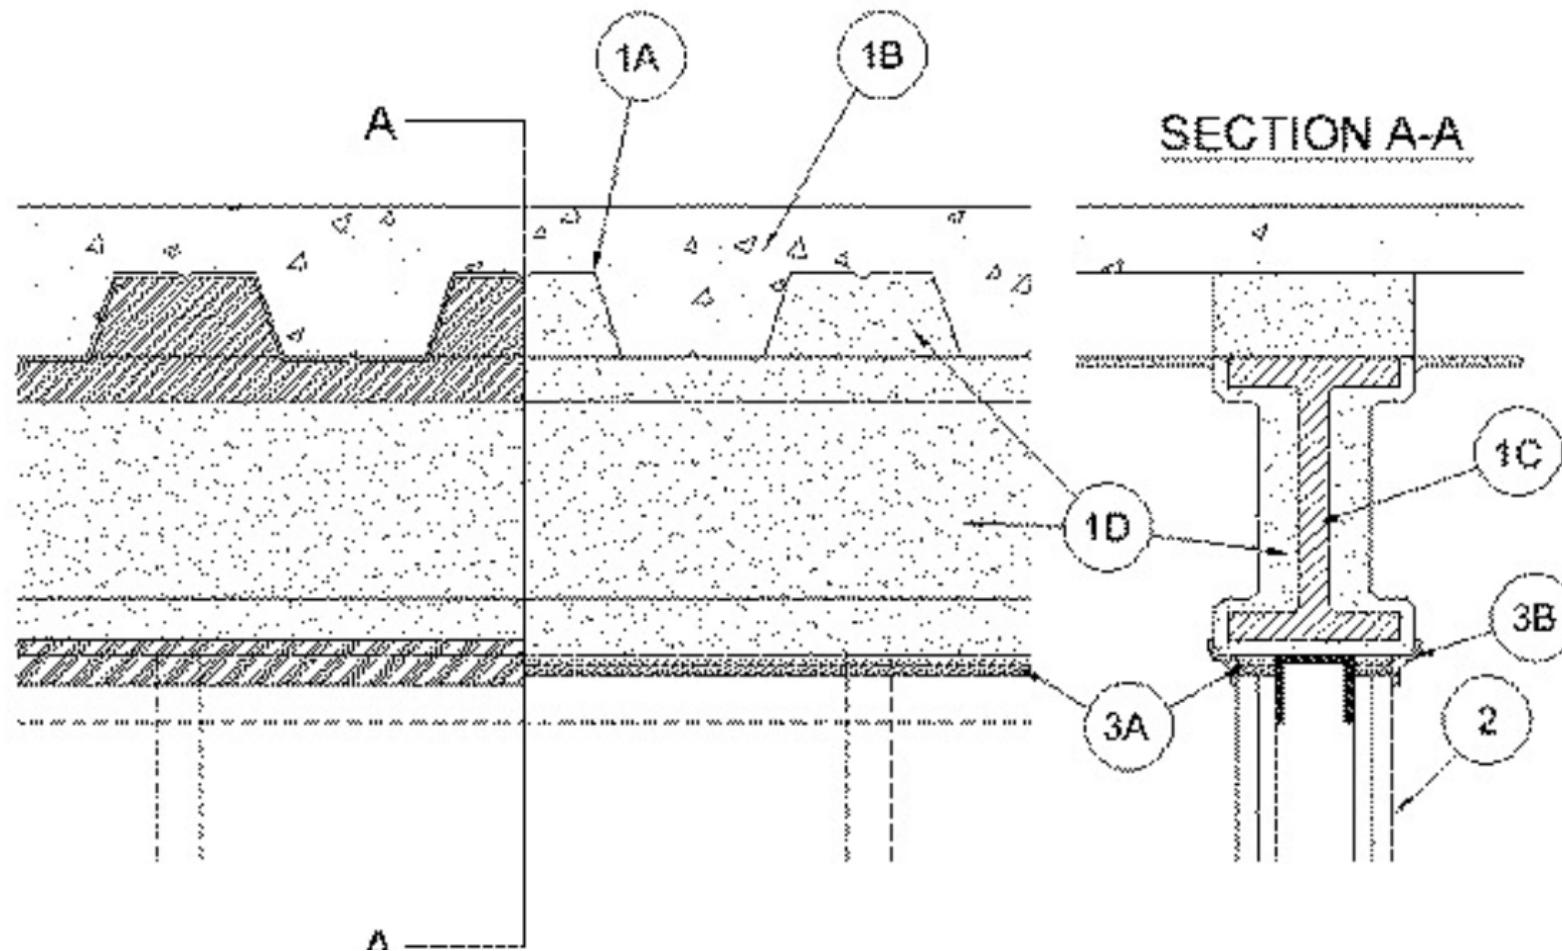
I-Beam to Fluted Deck OVER WALL HW-D-0259

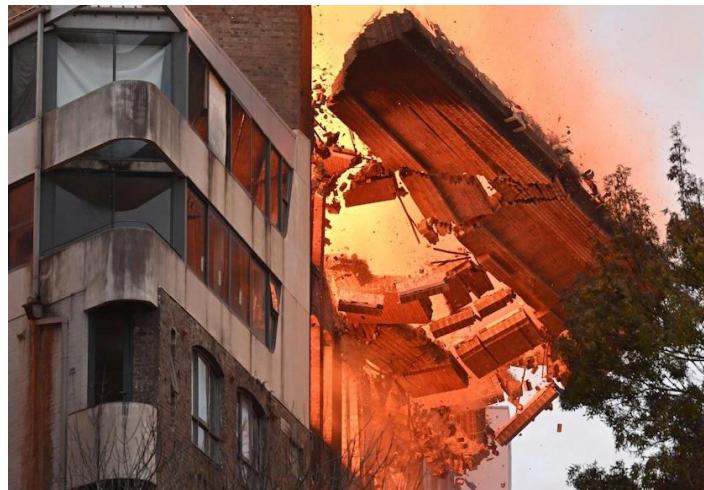
When exposed to high temperatures, the concrete's temperature will rise. As it rises, the **water within the concrete structure will start to evaporate** and leave the structure. This causes the concrete to begin losing its structural integrity. On extreme heating-concrete spalls.

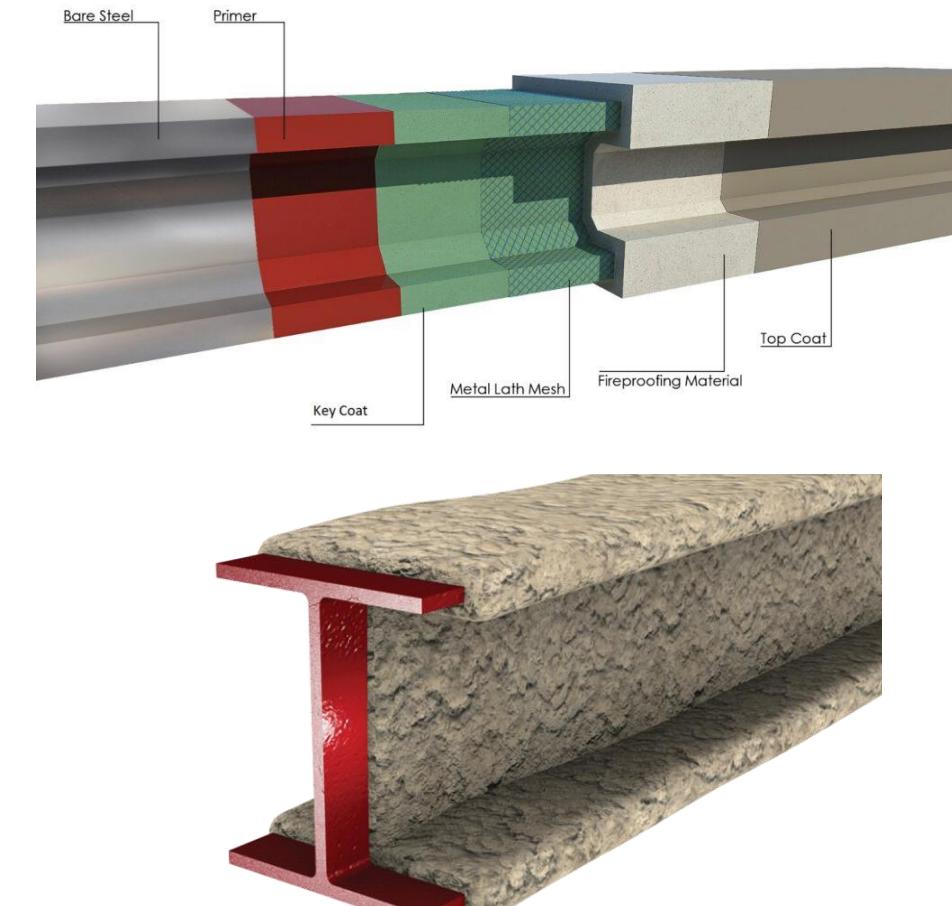
Structural protection

maintaining structural integrity (no buckling)
(e.g. for 2 hr in high-rises per NFPA 5000).

ASFRMs adheres to irregular steel profiles,
providing uniform coverage without impeding
construction, and is mandated by IBC Chapter 7
for Type I/II buildings to delay critical
temperature.

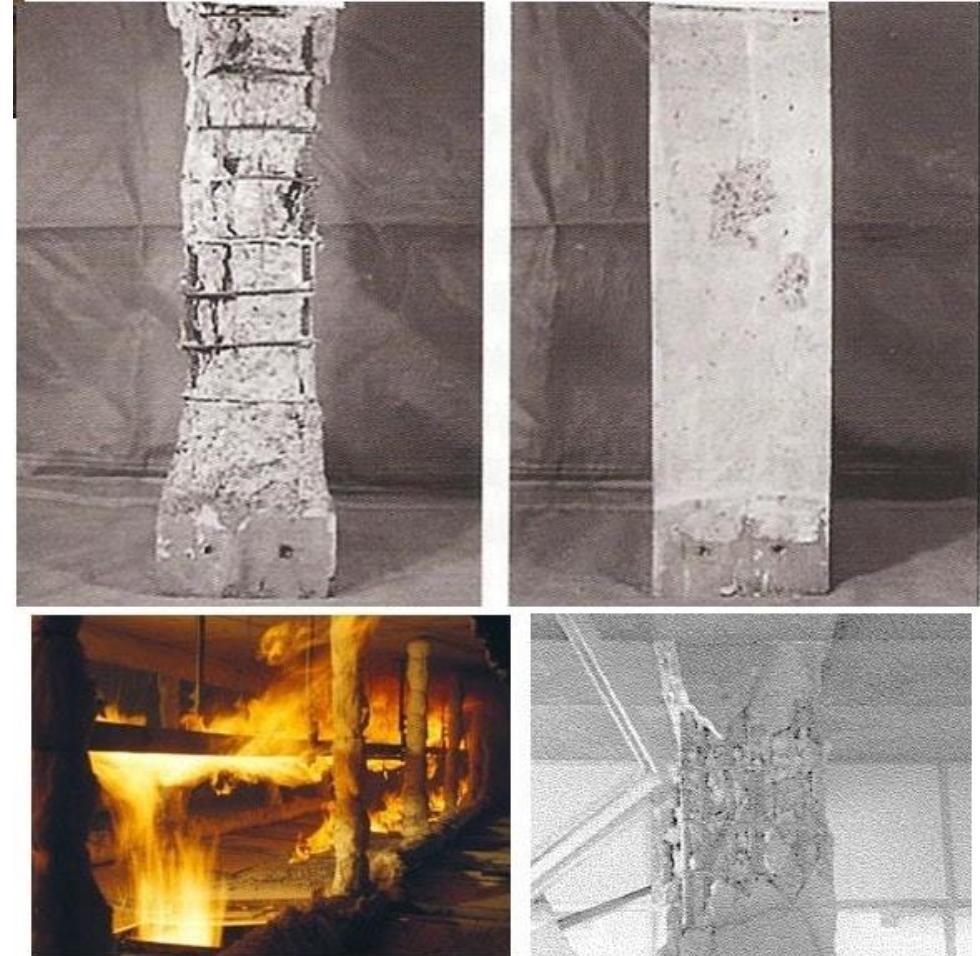
Inherent fire resistance & limitations

- Concrete's low thermal conductivity and high heat capacity naturally resist fire spread, maintaining structural integrity (compressive strength retained up to ~600°C per ASTM E119 testing).

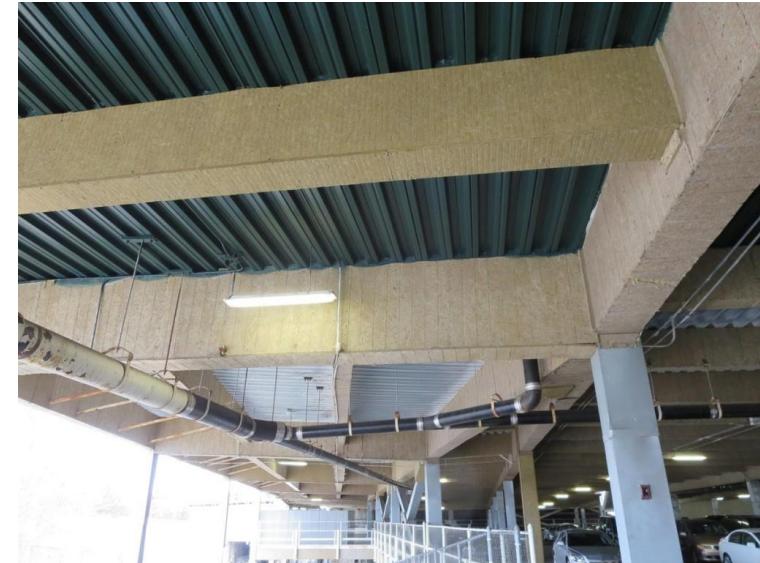
Types of protection

- **Spray-Applied Fire-Resistive Materials (SFRM)**
- **Intumescent Coatings**
- **Board Systems**
- **Outcome:** Ensures structural stability, limits temperature rise.

Everything has limitations.
Protection delays the point of failure.

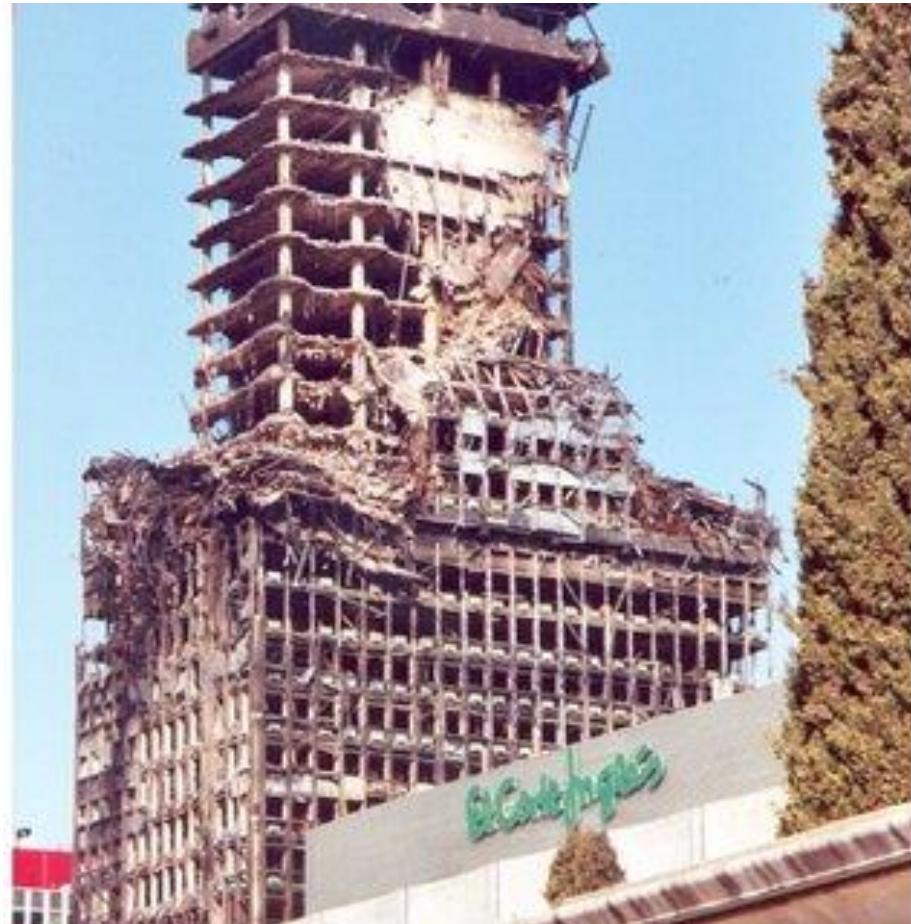
- Downward spread was slower (20-30 minutes per floor)
- fueled by falling debris
- Fueled by radiant heat through the façade
- Spread via internal paths like service voids and unsealed slab-cladding gaps
