The role of Passive Fire Protection

Dr Gabrielle Peck, BSc(Hons), Ph.D., MRSC,
Technical Director

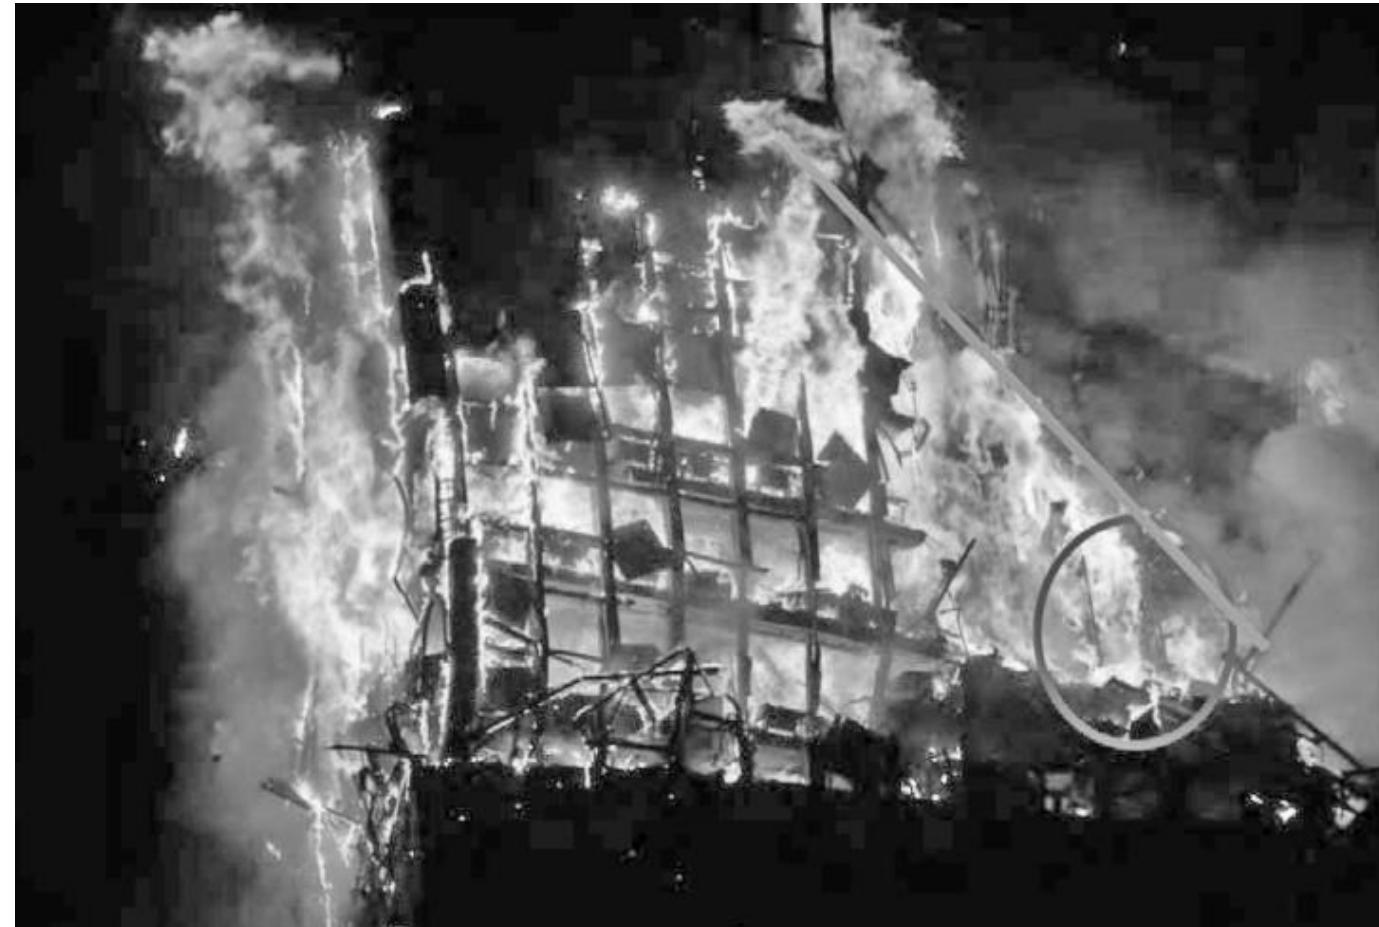
- Lacked operational sprinklers (retrofit)
- Had incomplete fire stopping → poor compartmentation.
- Blaze involved multiple floors simultaneously
- a "chimney effect" combined with very high fuel loading led to temperatures exceeding 1,000°C in spots.
- the **unprotected perimeter steel columns above the 17th floor heated exponentially buckling outward**

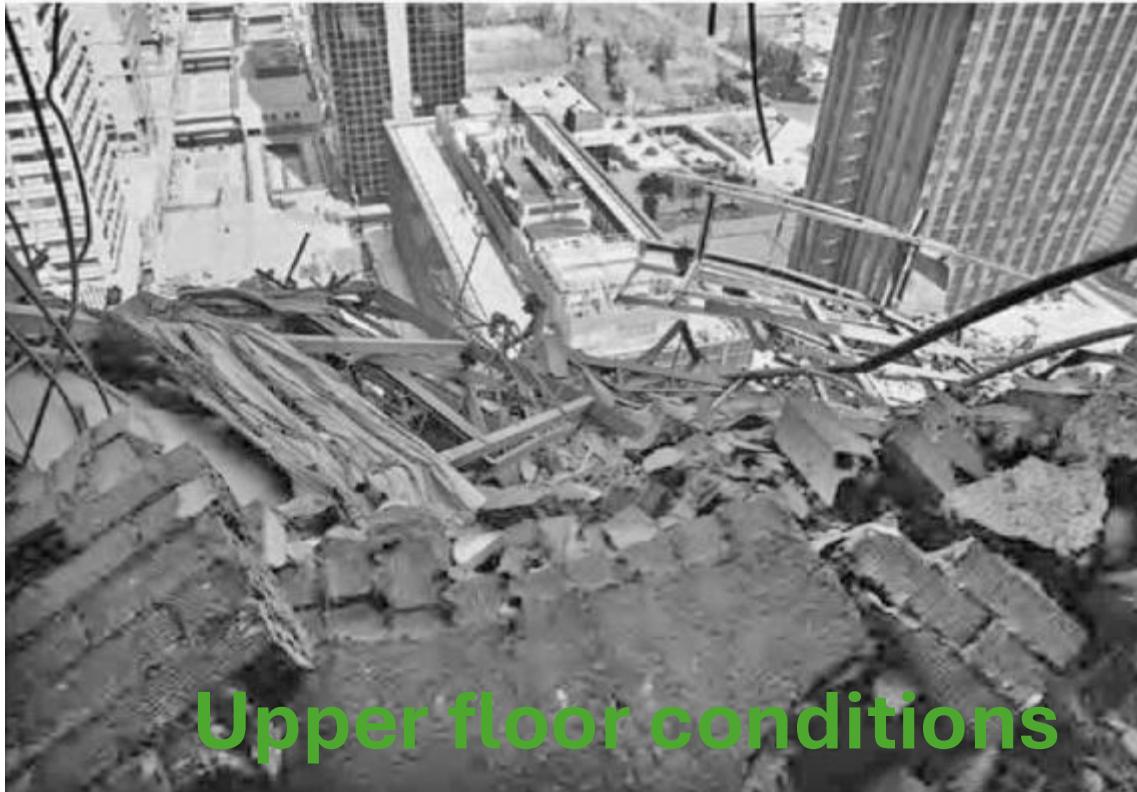
Upper floor conditions

- Below the 17th floor, **protected steel held**, but unprotected spots (e.g., 9th floor south/west sides) buckled
- The concrete core and internal columns redistributed loads, preventing further failure.

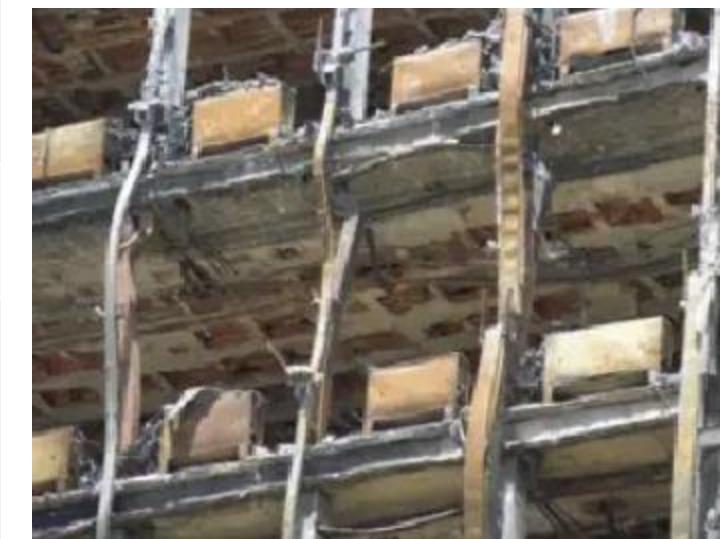
Buckling at floor 9

Fire protection system	At time of construction (1970s Spanish code)	At time of fire (under refurbishment)
Compartmentation	X	Under construction, but not fully compartmentalised
Fire stopping between cladding & Structure	X	Under construction
Protection of steel	X	17th floor + above: NO 18 th floor, part complete 4-15 th floor: Complete (except 9 and 15)
Sprinkler system	X	Being retrofitted
Fire alarm system	YES	YES
