# National Fireproofing Contractors Association Handbook of Accepted Fireproofing Knowledge

## Appendix 1:

### PATCHING SFRM INSTALLATIONS

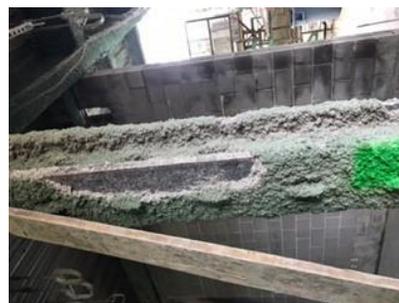
*SFRM can be damaged during construction, then repairs are needed. GCP Applied Technologies Photo*

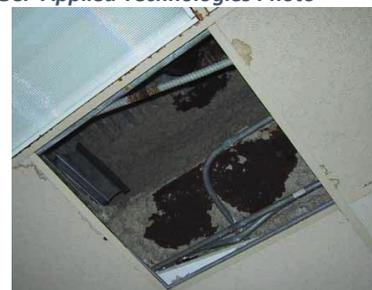
*SFRM can be damaged when new services are added to existing buildings and need repair and documentation of the repair to comply. GCP Applied Technologies Photo*
